*Church of the Ascension, Timoleague  
Conservation Report*

## **1.0 Introduction**

This report has been carried out on behalf of our clients, The Vestry of Kilgarriffe Union of Parishes, who requested a Conservation Plan for the Church of the Ascension, Timoleague. It is located in Cork County. The Church is a protected structure (RPS ID 01375) and is listed on the National Inventory of Architectural Heritage (Reg No. 20856005). It is an Anglican Church dating from the early 1800s, with later additions.

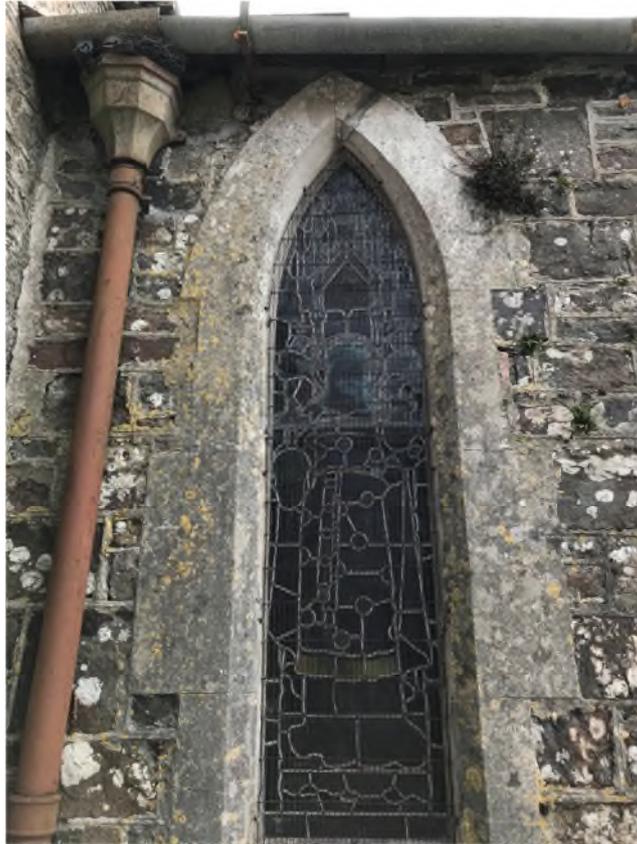
**Repaired crack at head of arch**

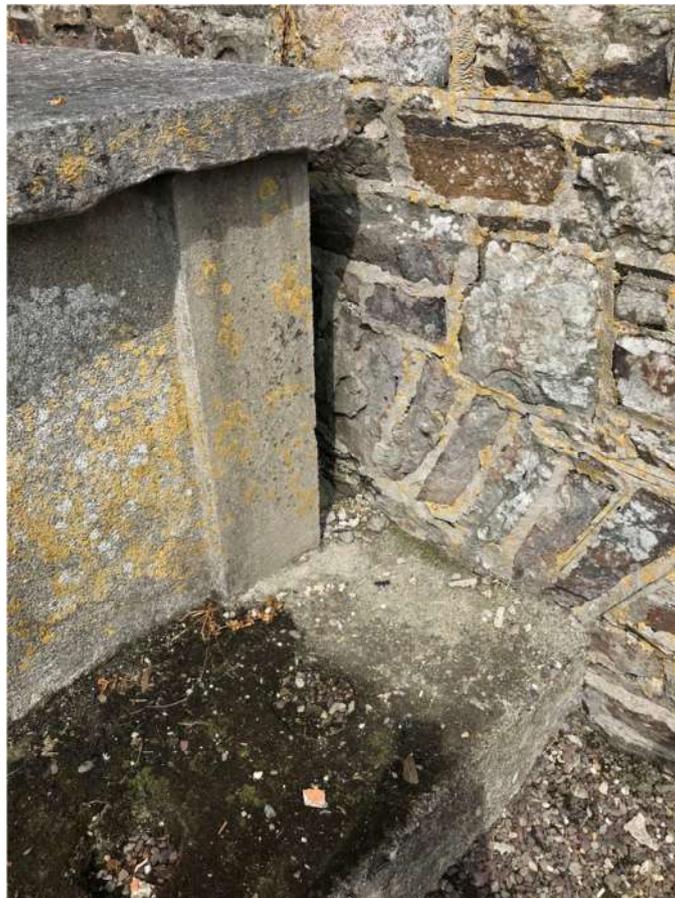
**Low level arch in south transept gable**

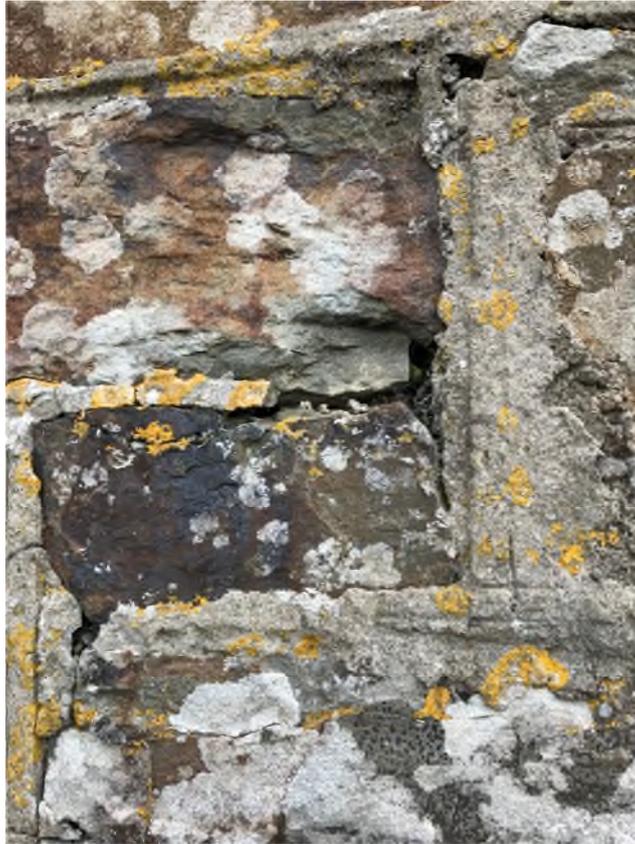
**Failing pointing**

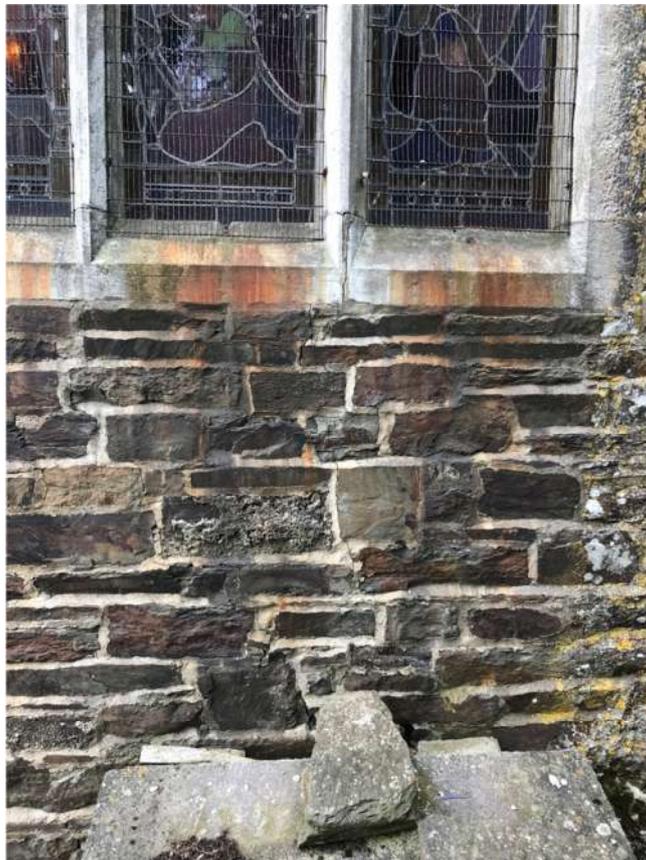
**Crack in east gable stone window frame  
and wall over below ground opening**

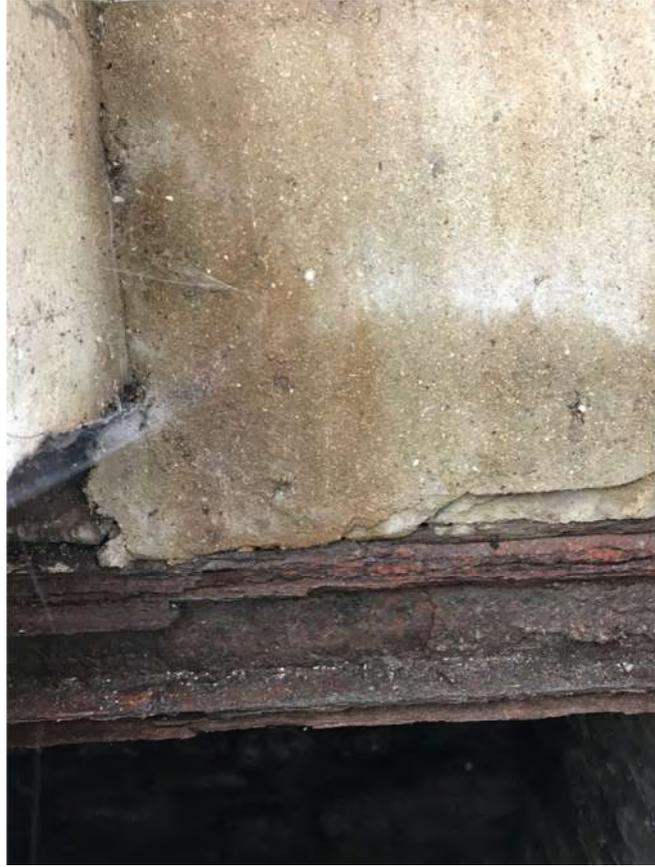
**Corroded iron lintel over below ground opening**

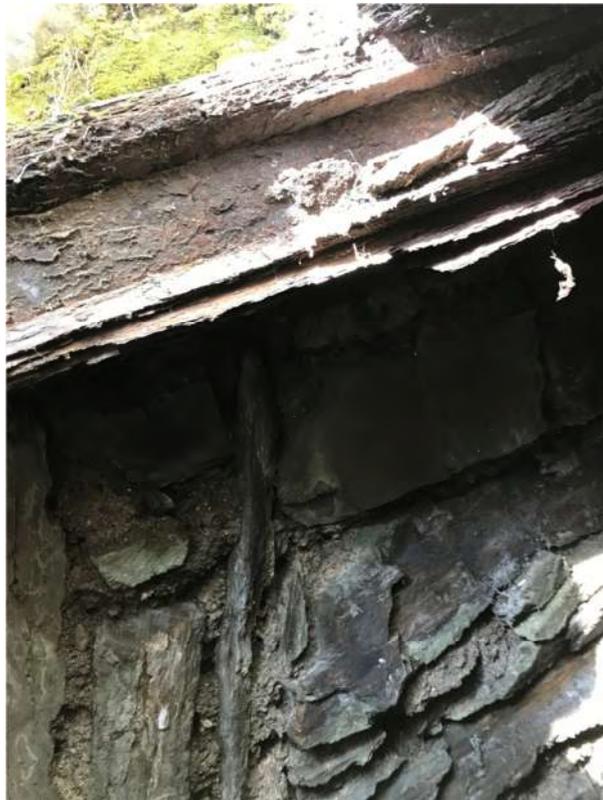
**Corroded iron lintel over below ground opening**

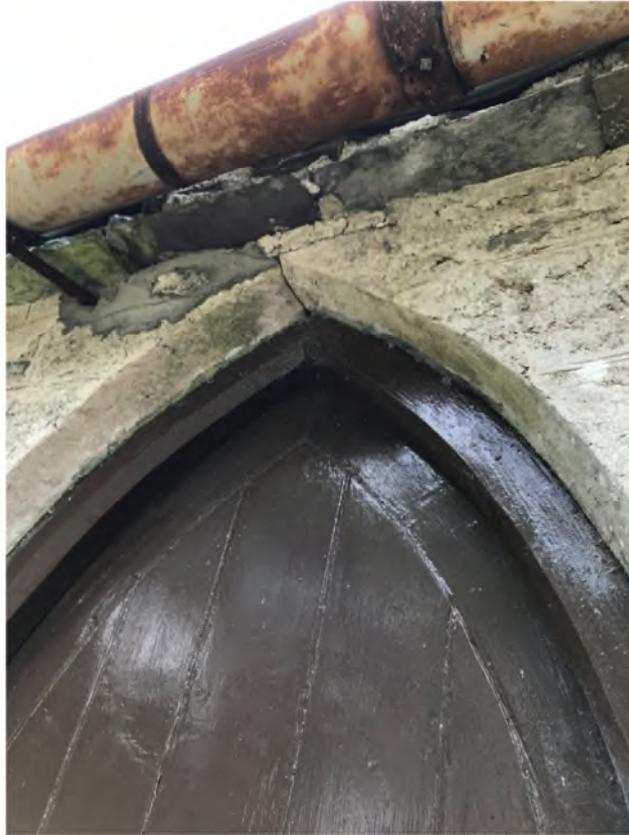
**Corroding gutter and bracket with modern repair  
at wall of damage to masonry from corroding bracket**

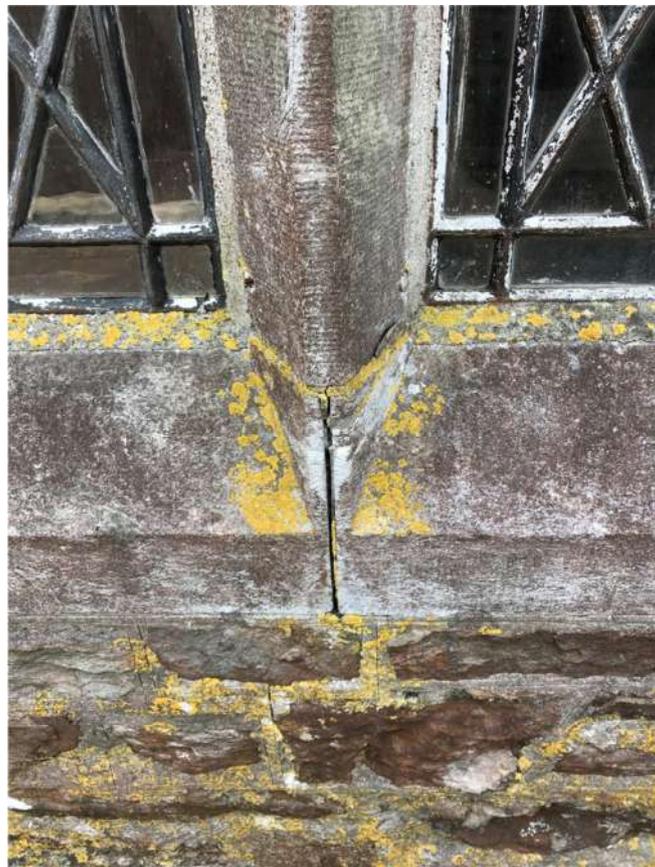
**Open joint at window surround**

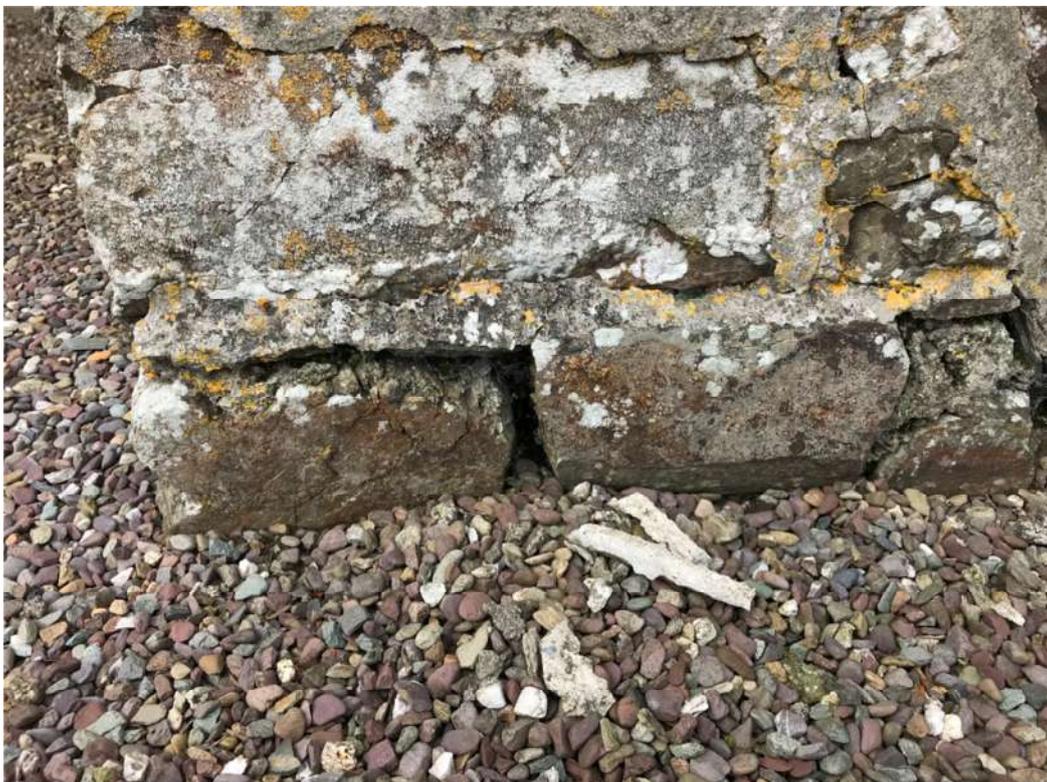
**Failed pointing and possible settlement at south-east corner of south transept**

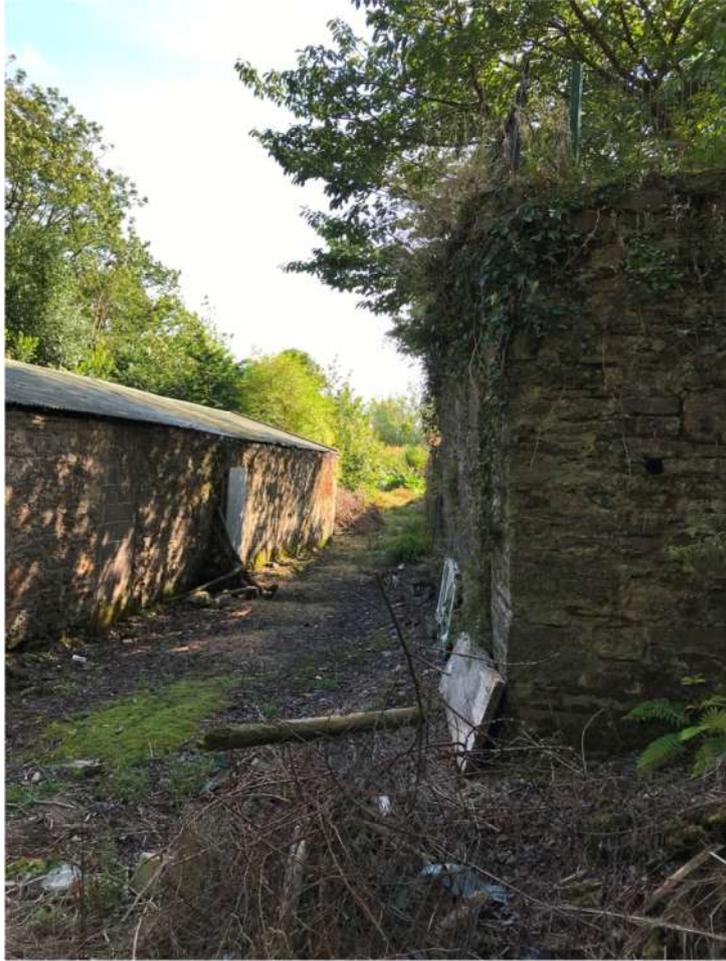
**Leaning retaining wall at east boundary of graveyard**

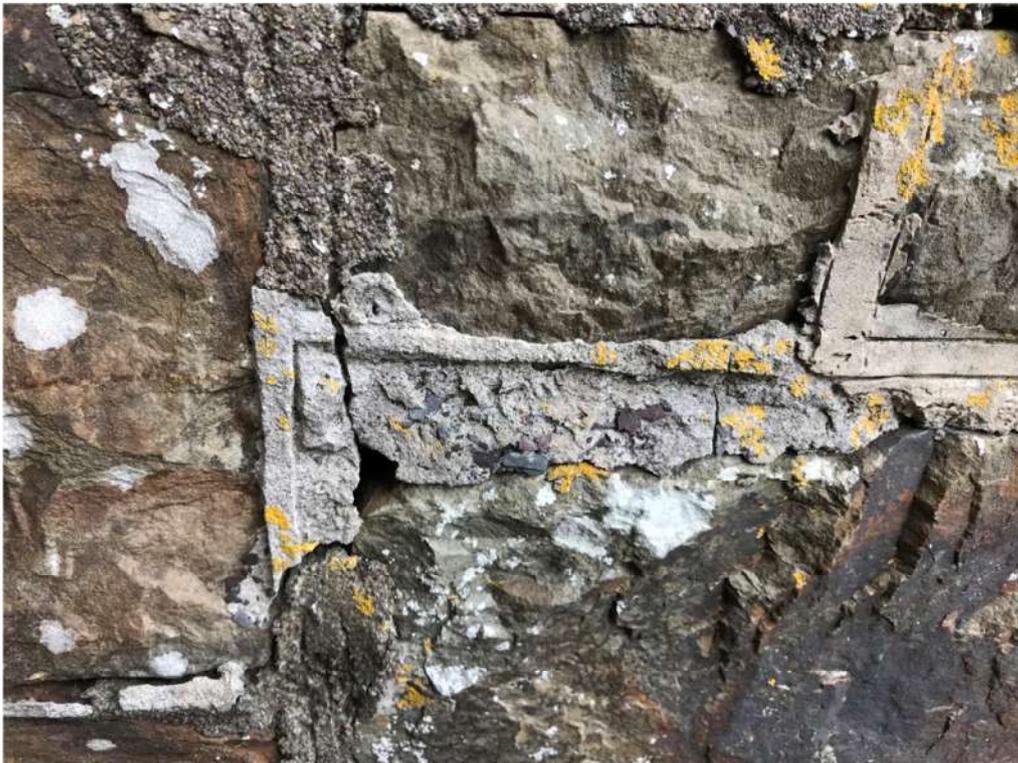
**Failure of repair to masonry pointing**

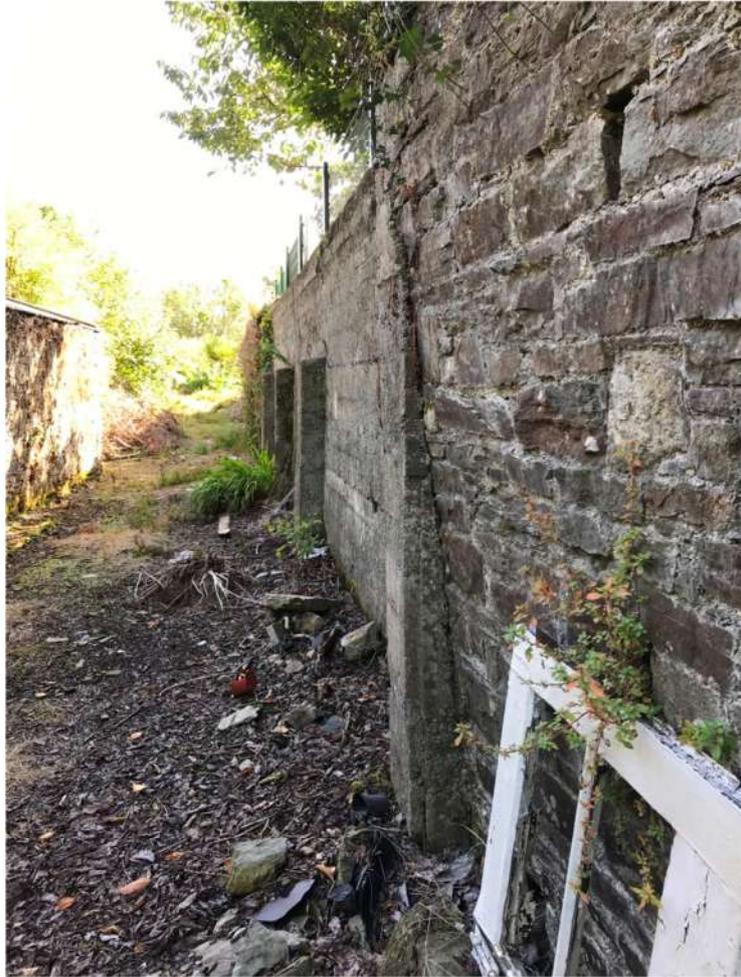
**East Boundary wall (note adjoining section has already been replaced)**

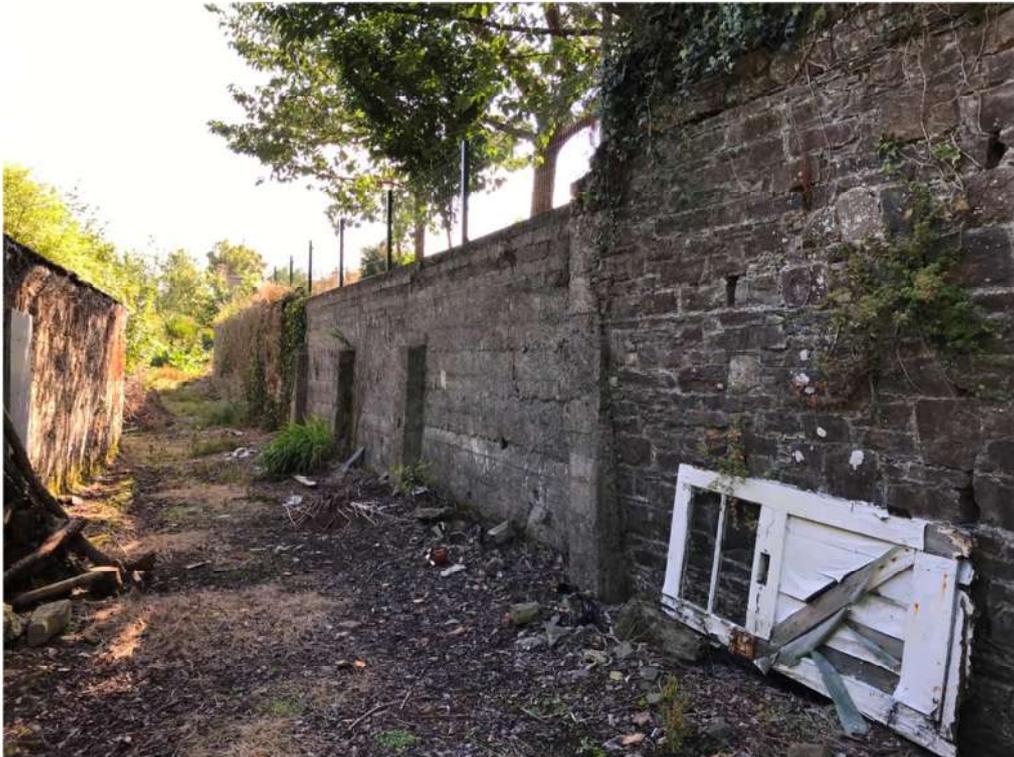
**East Boundary wall (note adjoining section has already been replaced)**

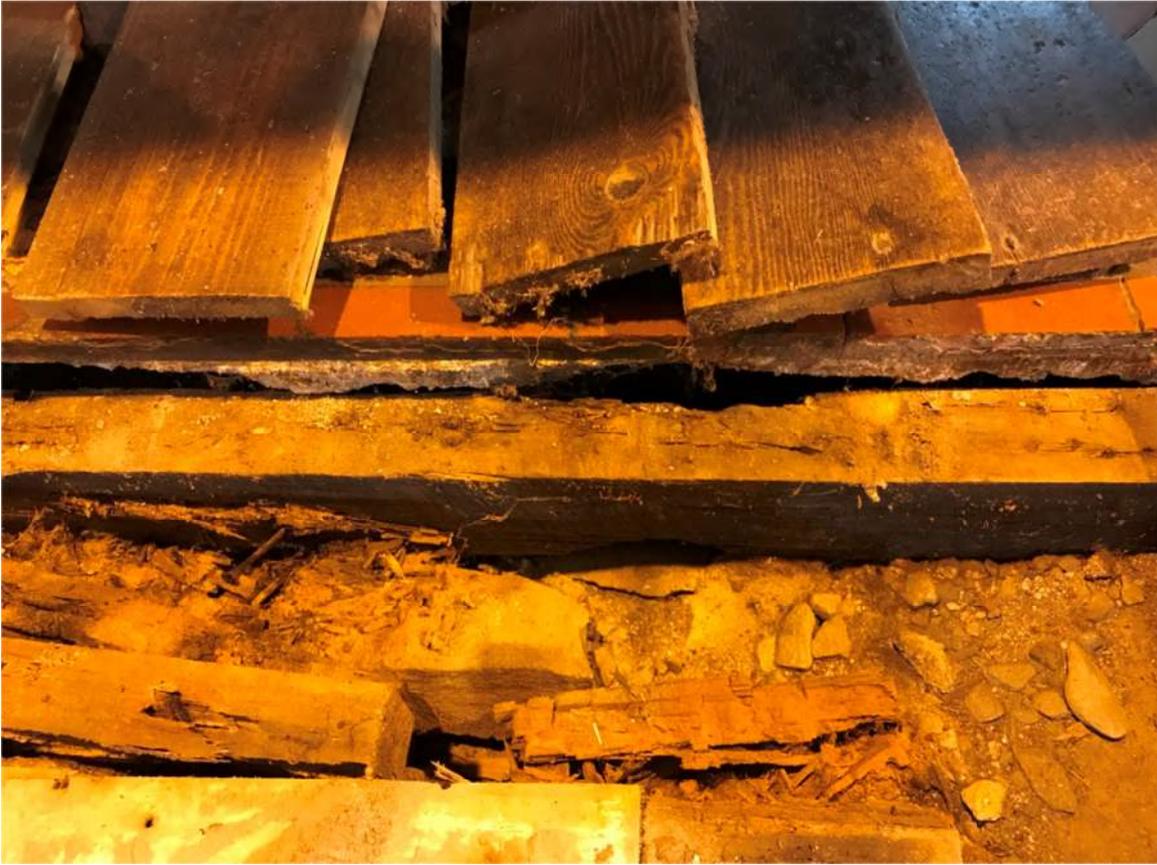
**Timber decay in suspended floor in nave**

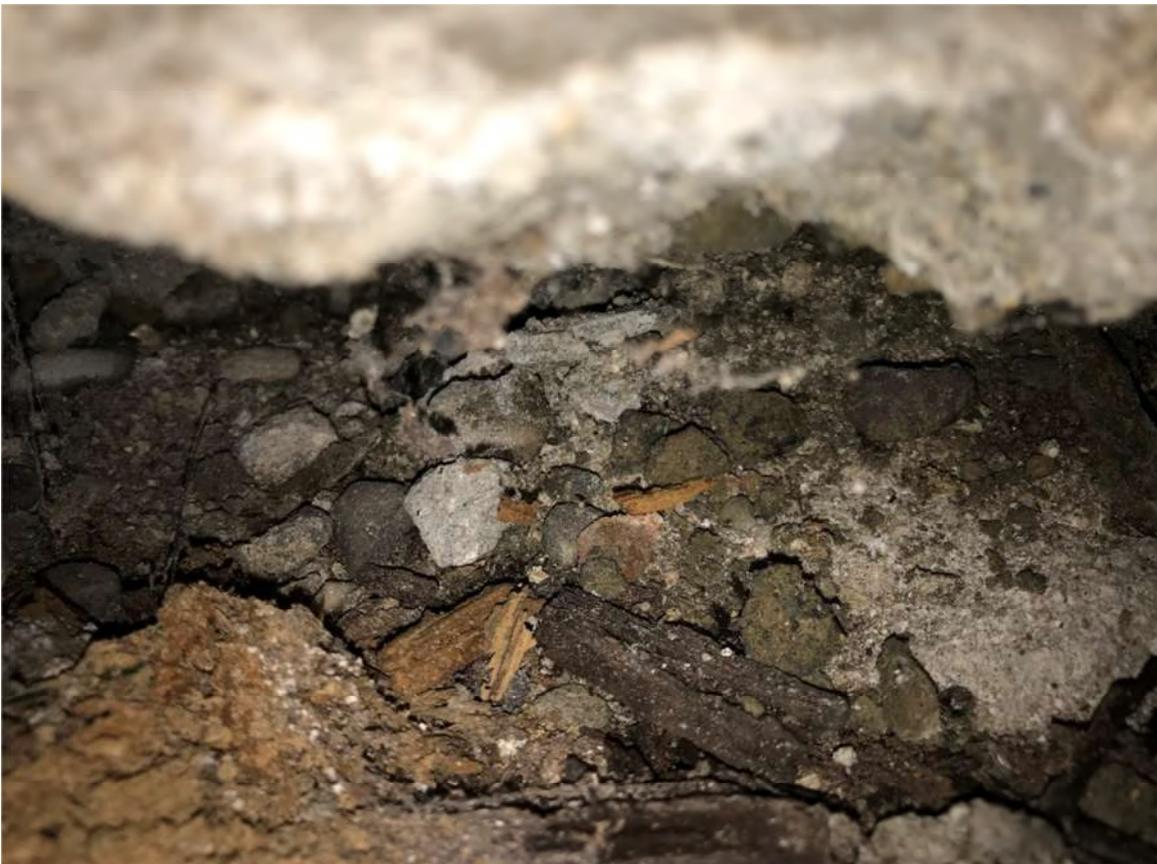
**Void due to settlement under solid floor at crossing**

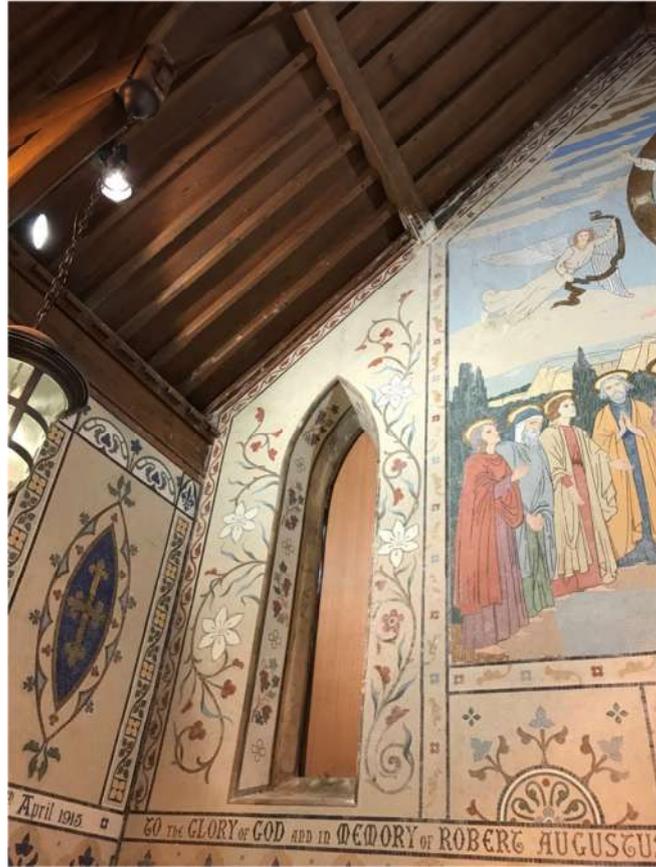
**Timber decay at purlin end and adjoining rafter**

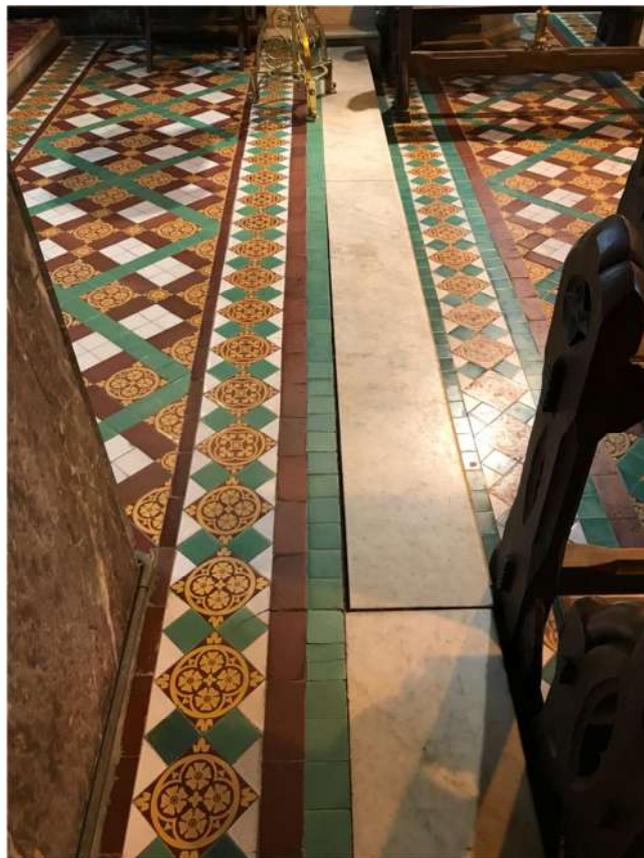
**Dislodged marble step at chancel floor edge**

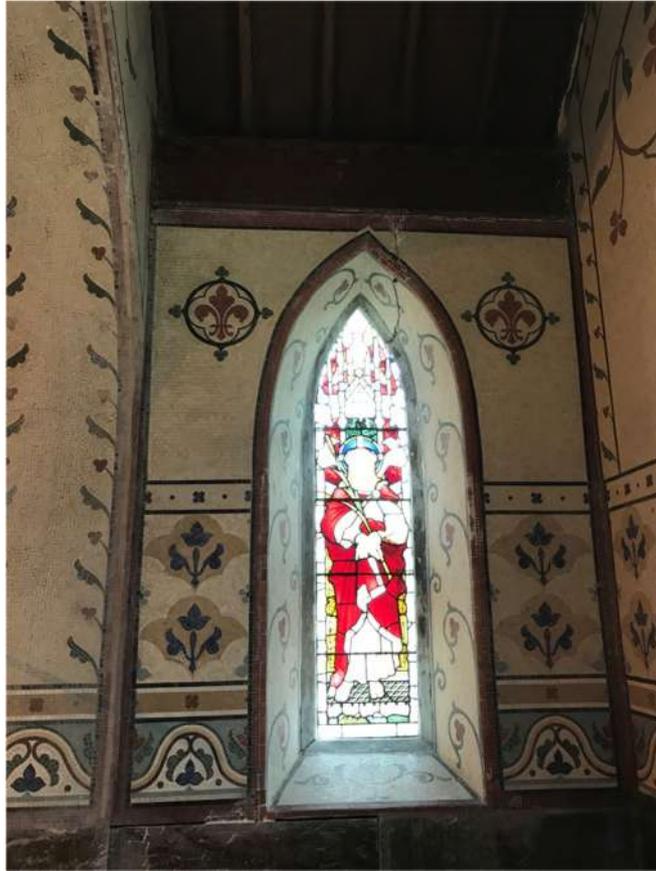
**Crack at South transept wall**

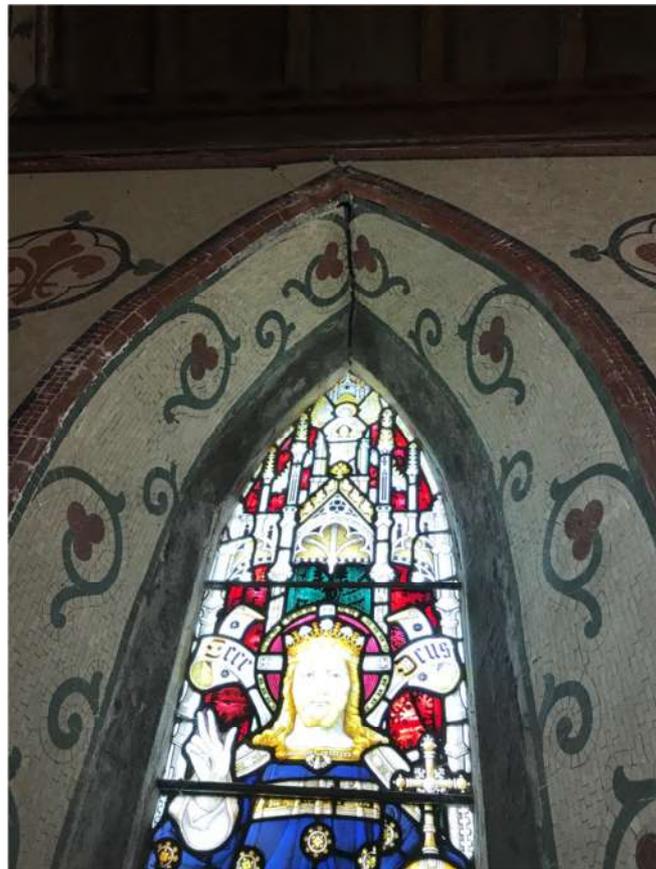
**Crack at South transept wall**

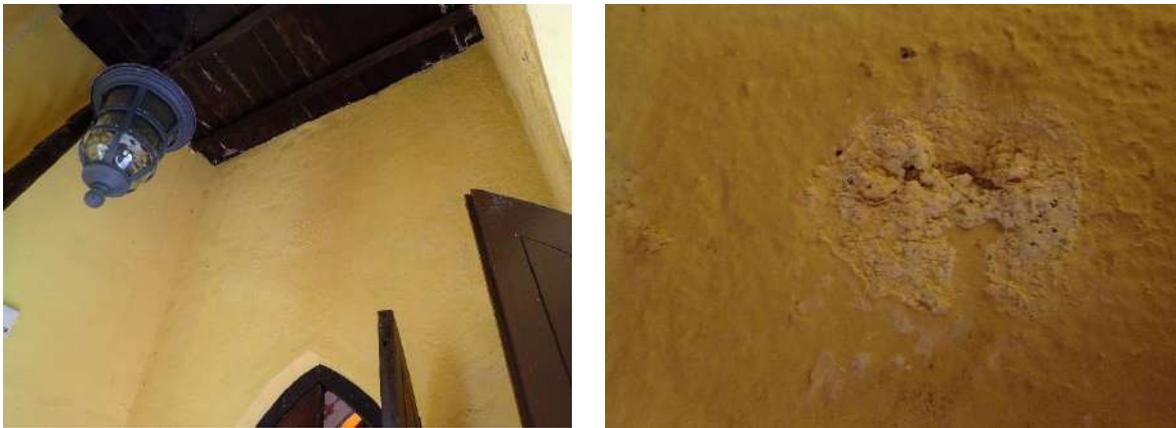
*Fig.4: Salts appearing on the surface of the painted wall surface at the base of the tower. This wall is not exposed to the exterior and indicates that the salts are not restricted to the mosaics and suggest that salts are diffuse throughout the masonry fabric.*

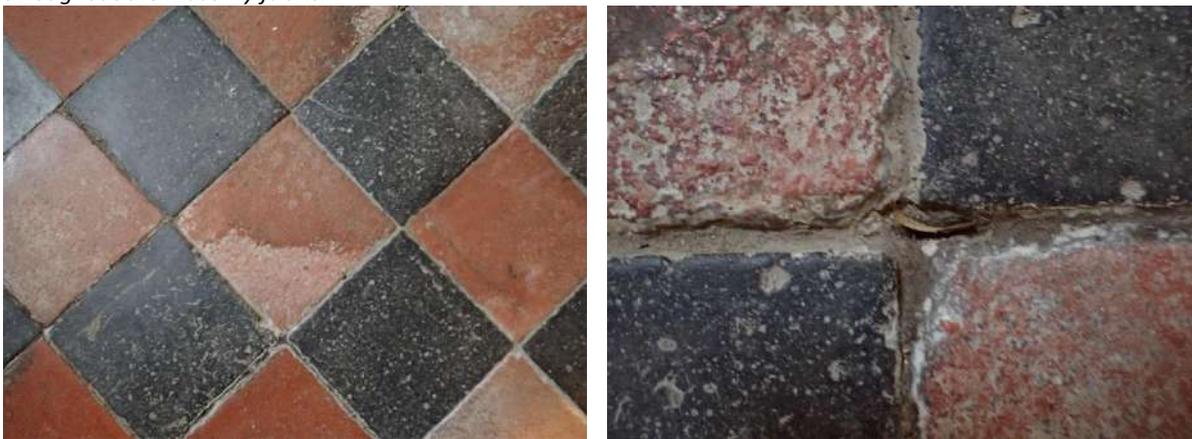
*Fig.5: Salt damage and salt crystallisation (right) on the stone floor at the base of the tower.*

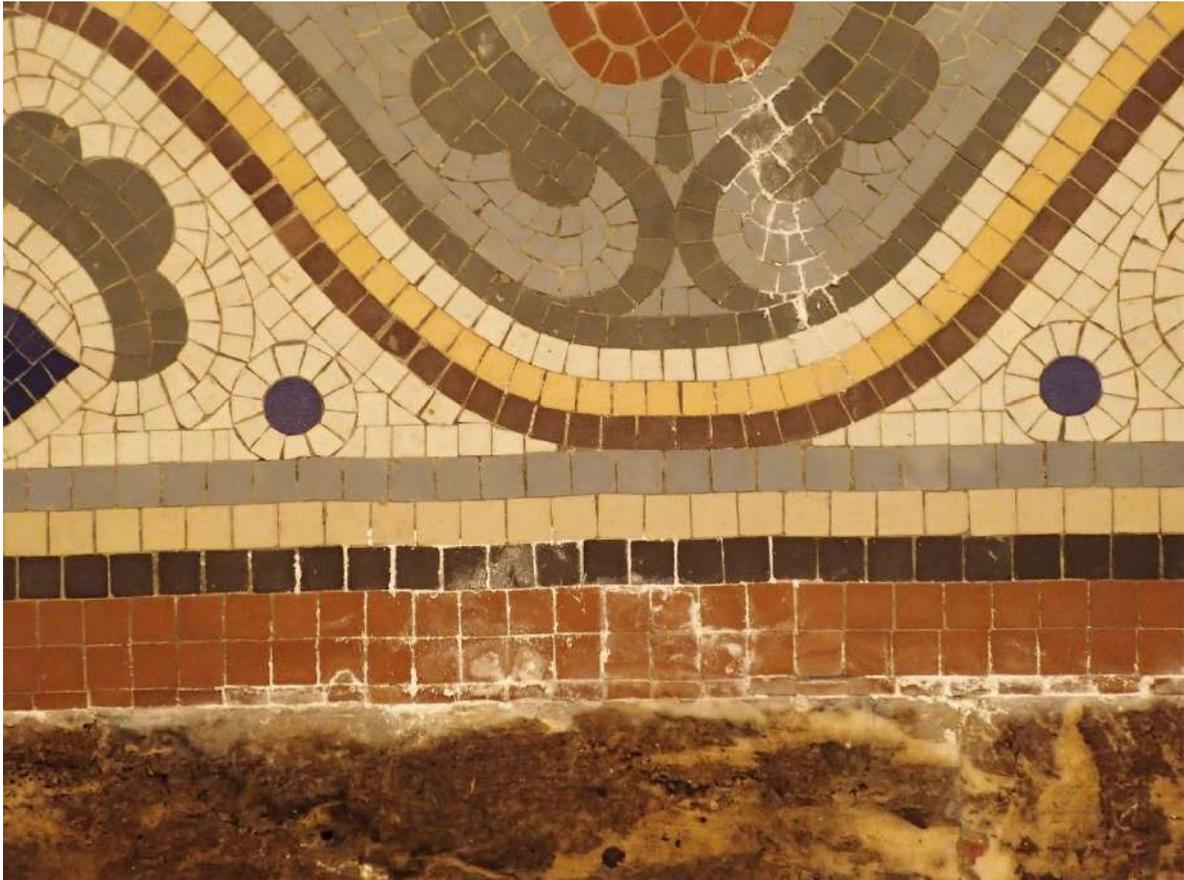
Fig.6: Salt typically appears within the mortars between tesserae and especially at angles between walls, at the edges of window opens and the interface between the mosaics and the marble plinth.

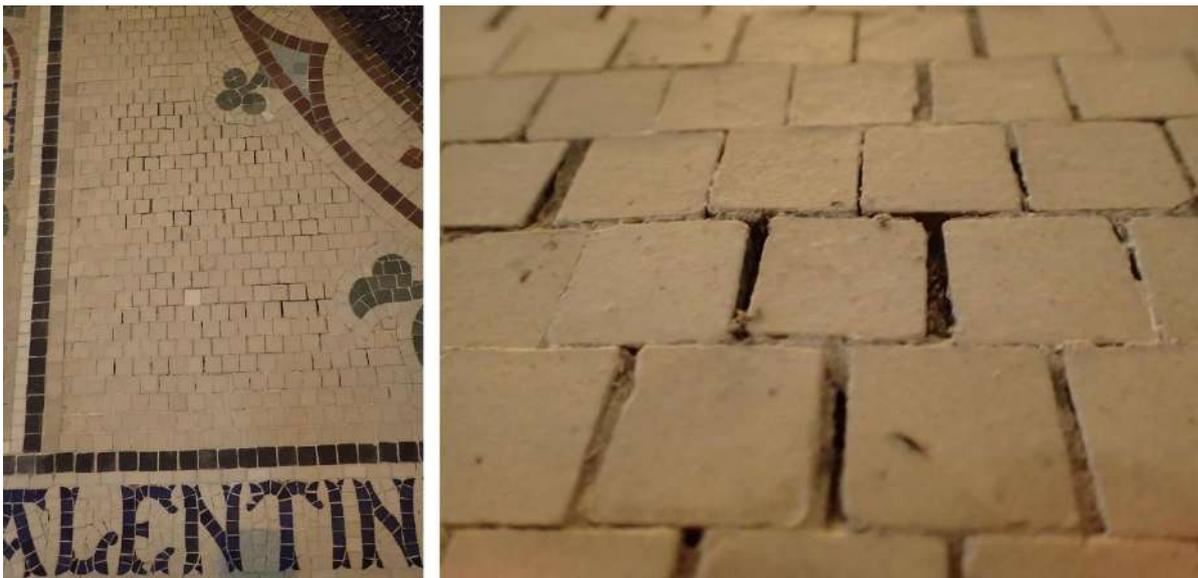
Fig.7: Dry joints in the tesserae along the north wall.

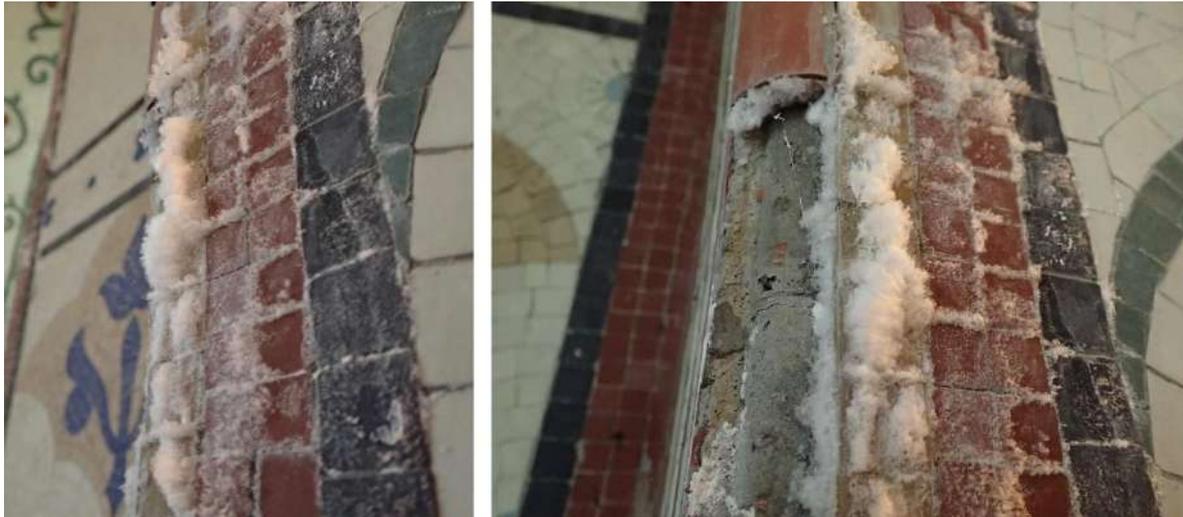
Fig. 16: Salt efflorescence and loss of angle tiles within the south transept.

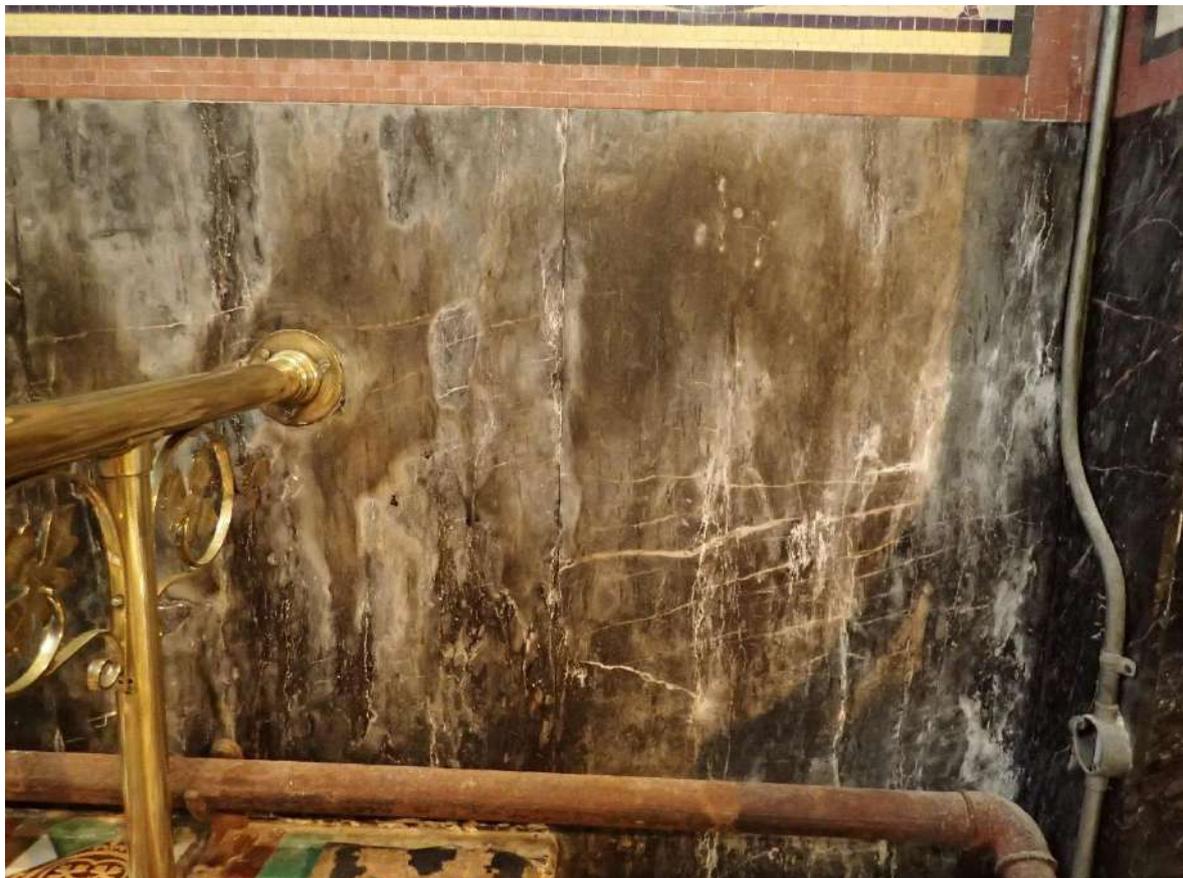
Fig.17: View of discolouration and salt efflorescence of the marble plinth, south wall, chancel.

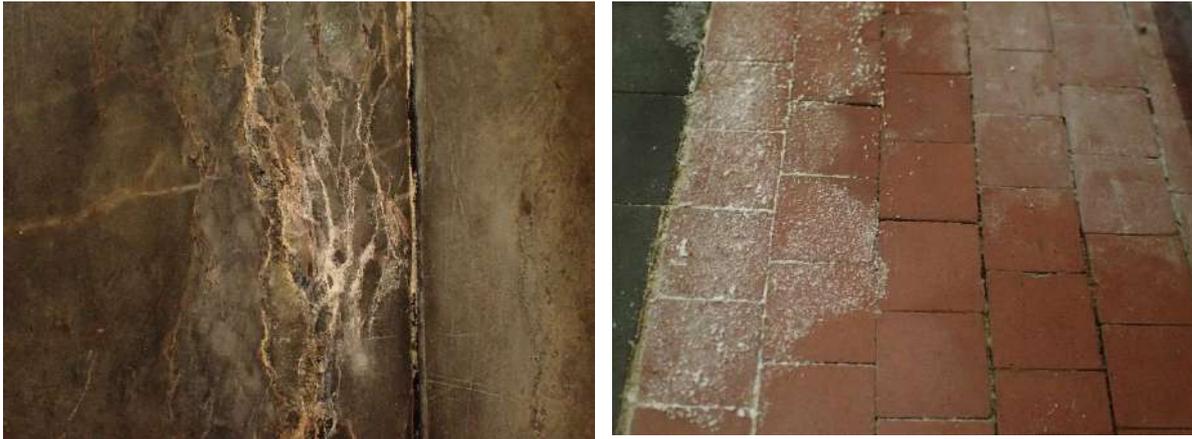
*Fig.18: Salt damage occurs throughout the wall surface. However, in the case of the decorative tiles, salt damage primarily affects the mortar joints and subsequently coats the surface of the tiles. For the marble plinth, salt action is much more damaging as it penetrates and crystallises within natural incipient fractures within the stone, causing not only crystallisation and coating, but damaging disruption of the stone fabric.*

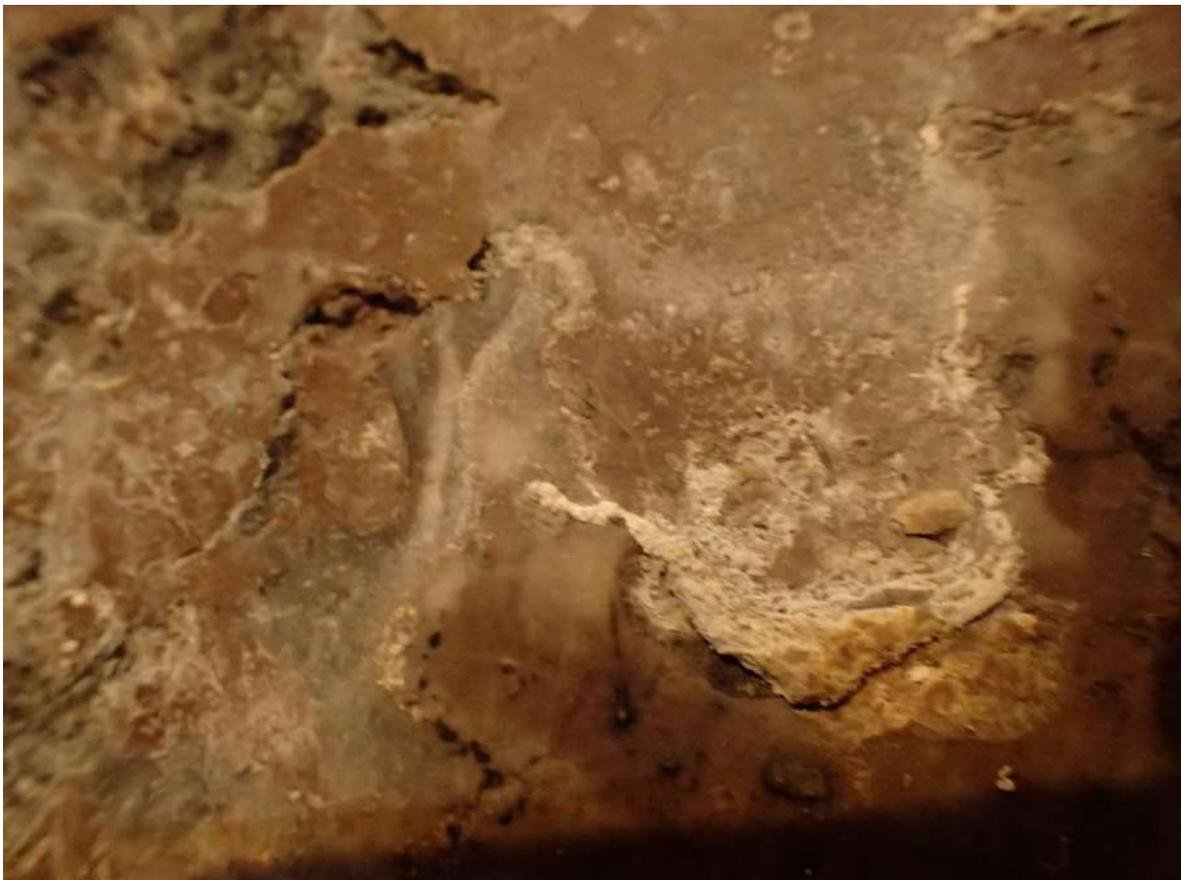
*Fig.19: Detail of salt crystallisation on the marble plinth at the west end of the south wall of the nave.*

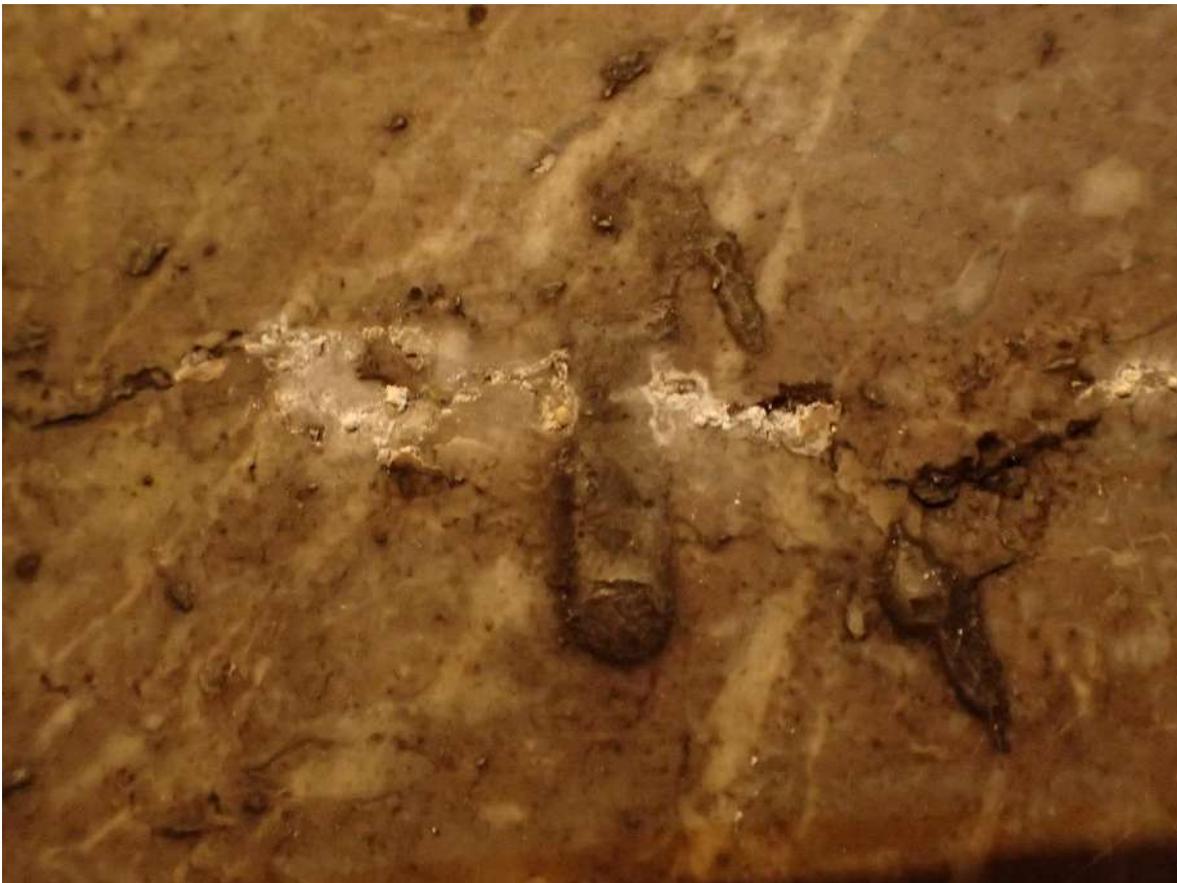
**4.1.3 Damage to Marble Plinths:** The combined action of moisture and salts leading to salt crystallisation, dry joints, and detachment of tiles is also seriously affecting the marble slabs ‘face-bedded’ to form the decorative plinth within the chancel and nave (Figs.17-20). While salt action damages the mortar between and underlying the tiles (e.g. Fig.16), salt action is directly more damaging to the marble plinths as it penetrates natural weaknesses in the stone, discolouring the surface of the stone (Fig.16) and enlarging natural fractures (Fig.21) leading to stone decay.

Fig.21: Salt efflorescence passing through natural fractures in the marble plinth on the south wall of the nave.

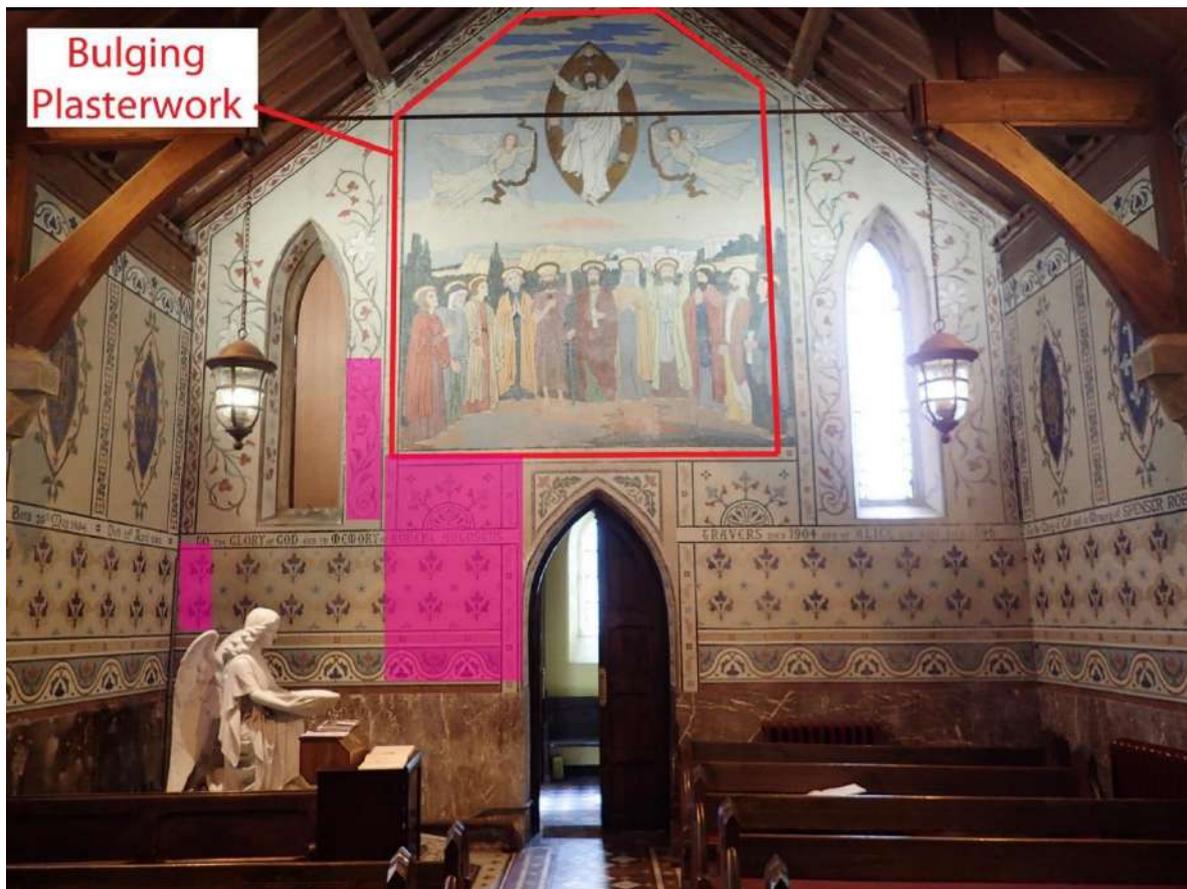
**4.2 Potential Detachment of Sections of Plasterwork:** In addition to salt crystallisation, mortar loss and detachment of individual tiles, some areas show bulging of plasterwork (e.g. Fig.23). This is most noticeable above the doorway on the west gable and along the north elevation, but is beginning to be apparent in other small areas also (e.g. within the south transept).

The bulging of plasterwork poses a significant risk to the mosaics as unlike mortar loss, tile detachment and salt crystallisation which affect individual or small number of tesserae and tiles, the failure of sections of the underlying plaster would result in both loss of the artwork, and potentially poses a risk to any churchgoers.

Fig.23: Area of bulging plasterwork supporting the mosaics of the west gable. The pink areas indicate areas showing salt crystallisation (see Fig.10 also).

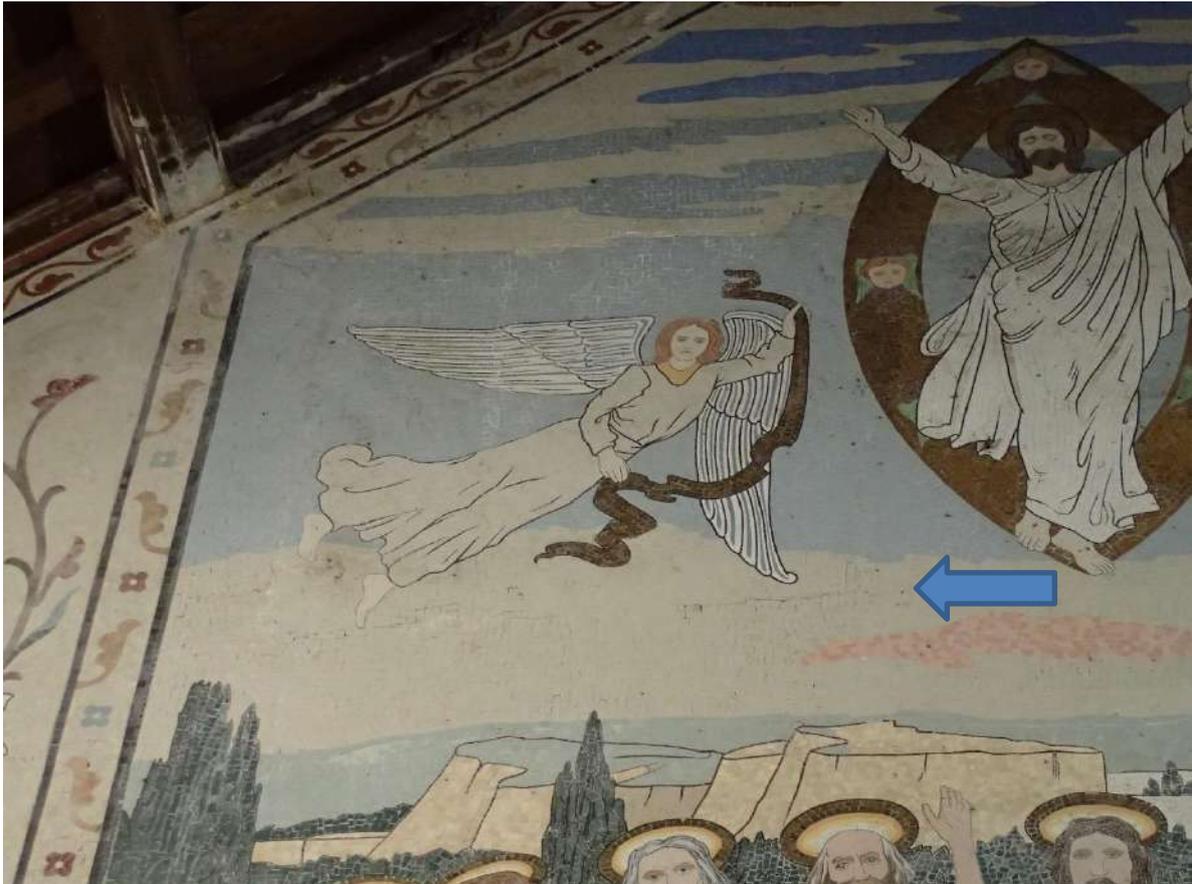
Fig.24: The plaster beneath the mosaics is bulging resulting in cracks (e.g. arrowed) appearing in the mosaic above the doorway in the west gable wall of the nave.
