*Church of the Ascension, Timoleague  
Conservation Report*

## **1.0 Introduction**

This report has been carried out on behalf of our clients, The Vestry of Kilgarriffe Union of Parishes, who requested a Conservation Plan for the Church of the Ascension, Timoleague. It is located in Cork County. The Church is a protected structure (RPS ID 01375) and is listed on the National Inventory of Architectural Heritage (Reg No. 20856005). It is an Anglican Church dating from the early 1800s, with later additions.

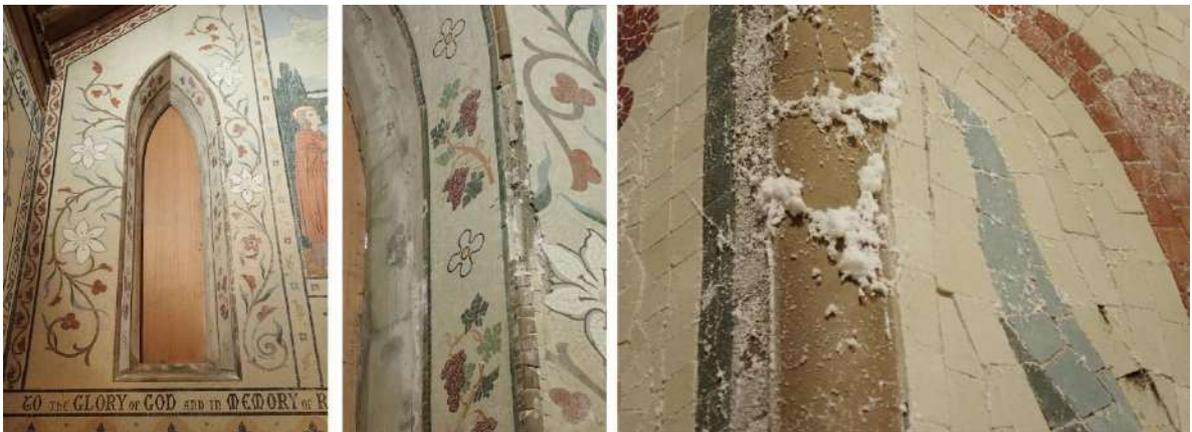
Fig.25: The bulging areas have some overlap with areas of salt crystallisation and loss of tiles (e.g. south side of the west gable wall) but should be considered a more serious risk.

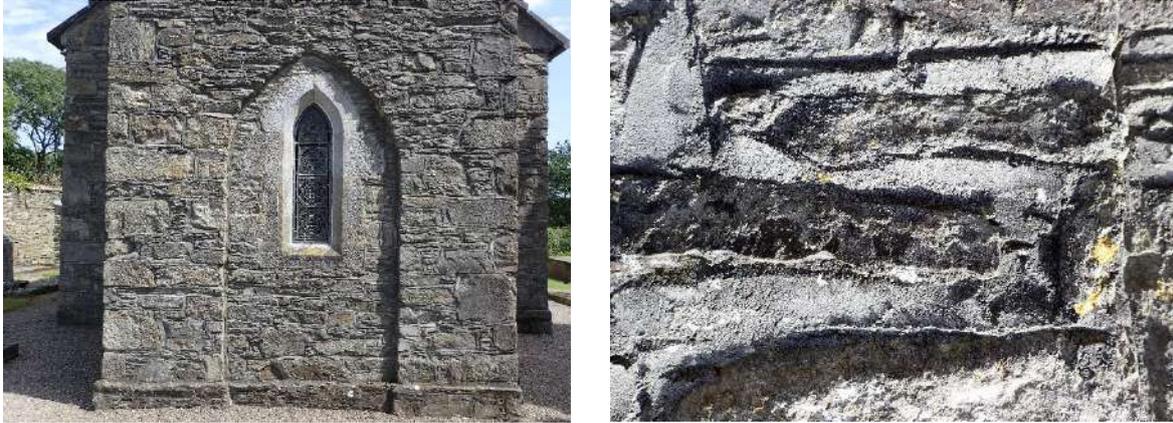
*Fig.26.: Detail of the base of west elevation of the tower pointed with Portland Cement mortars.*

The building stone of the church is in relatively good condition (Figs.26-27) and there are no well-developed decay forms indicating that the Portland Cement-based mortars are not directly incompatible with the stone. However, the function of the pointing mortars are not only to bind the stone, but to protect from moisture ingress and in this regard the Portland Cement repointing has failed. These mortars have lost their bond with the masonry in many locations (Figs.29-30), allowing moisture ingress into the building fabric but preventing evaporation resulting in a very likely saturated fabric. This saturation is indicated by the vegetation growing in the joints of the south transept (Fig.28) and is directly associated with the failures seen on the wall mosaics internally.

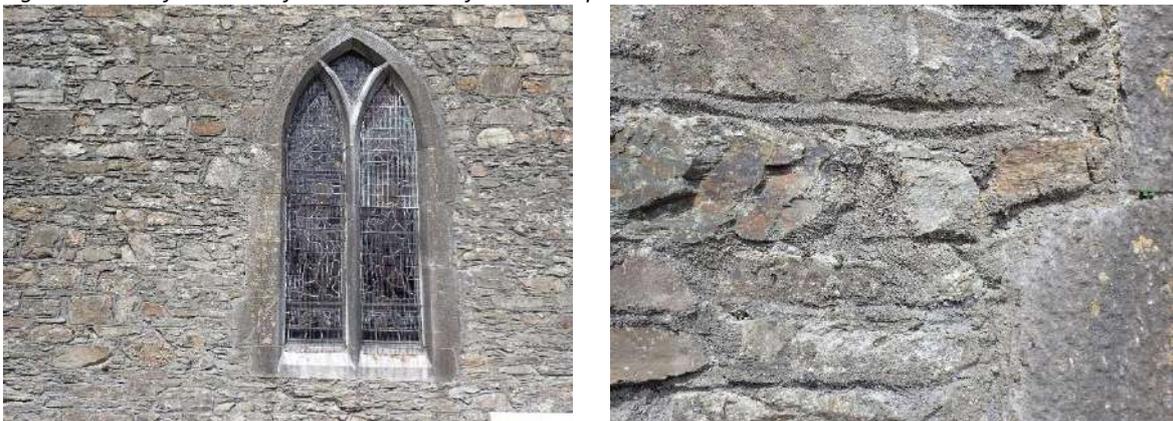
*Fig.27: Detail of the south elevation, repointed with Portland Cement-based mortar.*

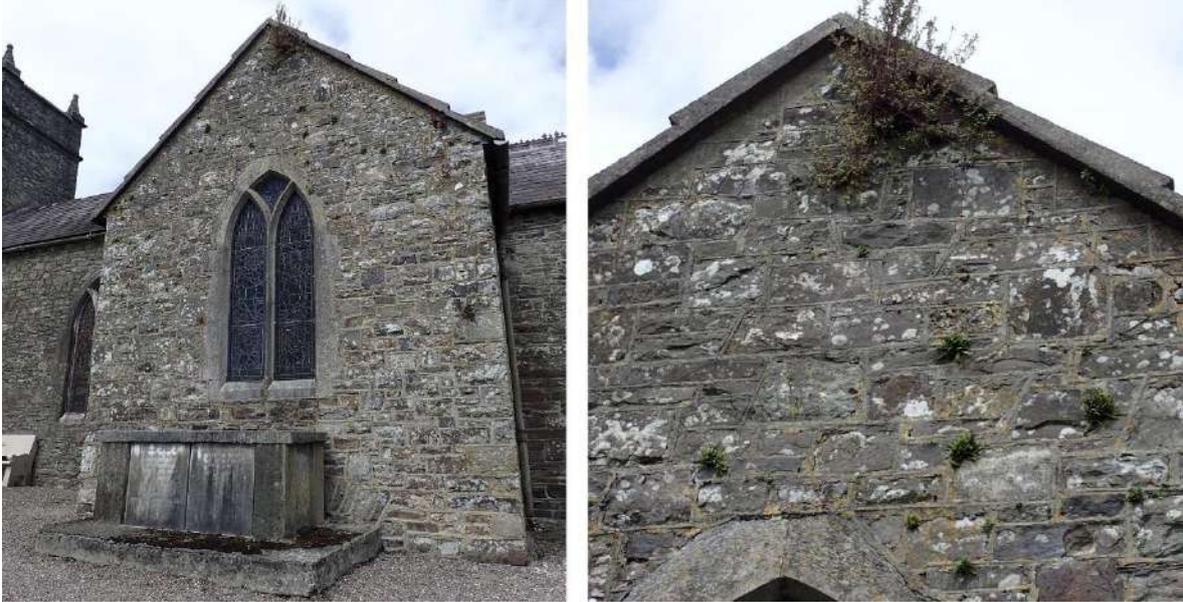
Fig.28: Vegetation growing in the failed Portland Cement repointing of the south transept.

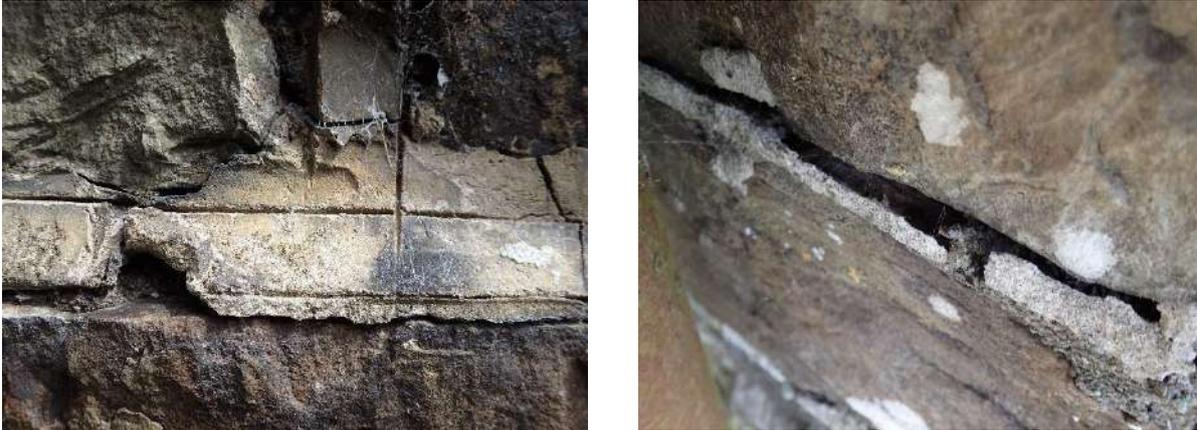
Fig.29: Detail of loss of bond between the Portland Cement pointing and the masonry allowing moisture ingress.

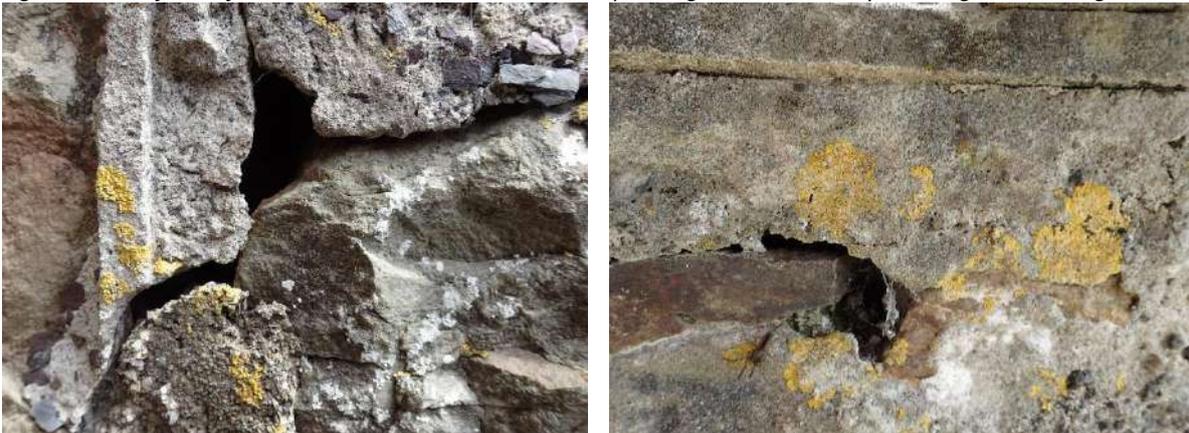
Fig.30: Detail of loss of bond between the Portland Cement pointing and the masonry allowing moisture ingress.

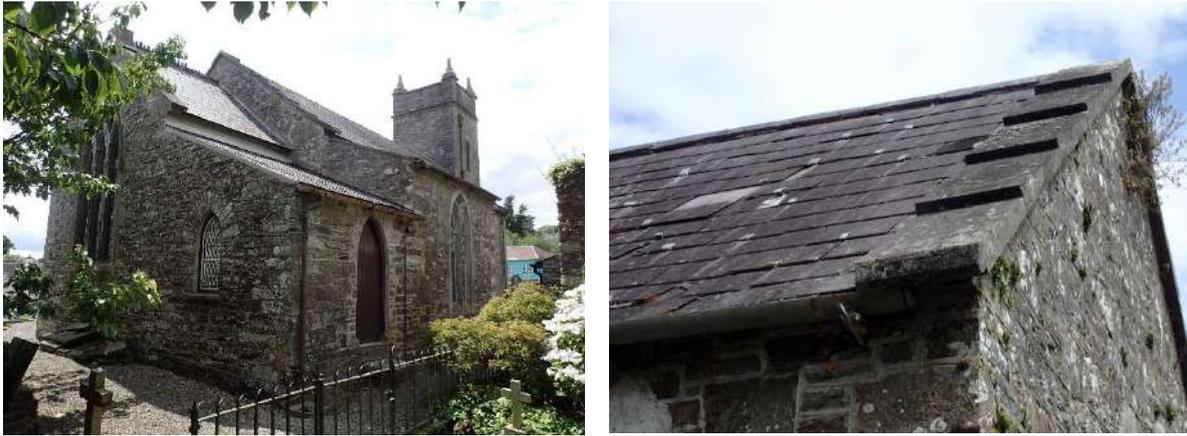
**4.4 Roof:** The roof shows some slipped slate and vegetation growing adjacent and possible beneath the coping stones (Figs.28, 31 & 32). Failure at the roof in combination with the presence of impermeable Portland Cement-based repointing mortars would result in a saturated wall fabric and cause and/or exacerbate the moisture and salt-related damage seen on the mosaics internally.

Fig.31: The church is roofed with natural slate, with some extensions to the roof to accommodate later enlargement of the church.

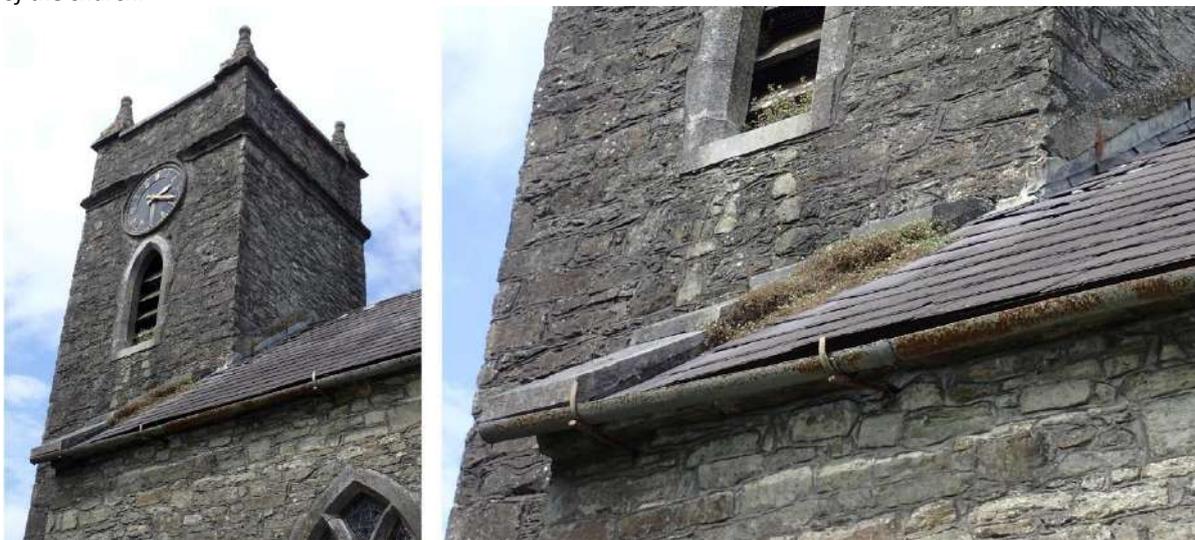
Fig.32: The roof was not closely examined but slipped tiles and vegetation at the coping stones indicate possible points of moisture ingress and that the roof requires closer inspection.

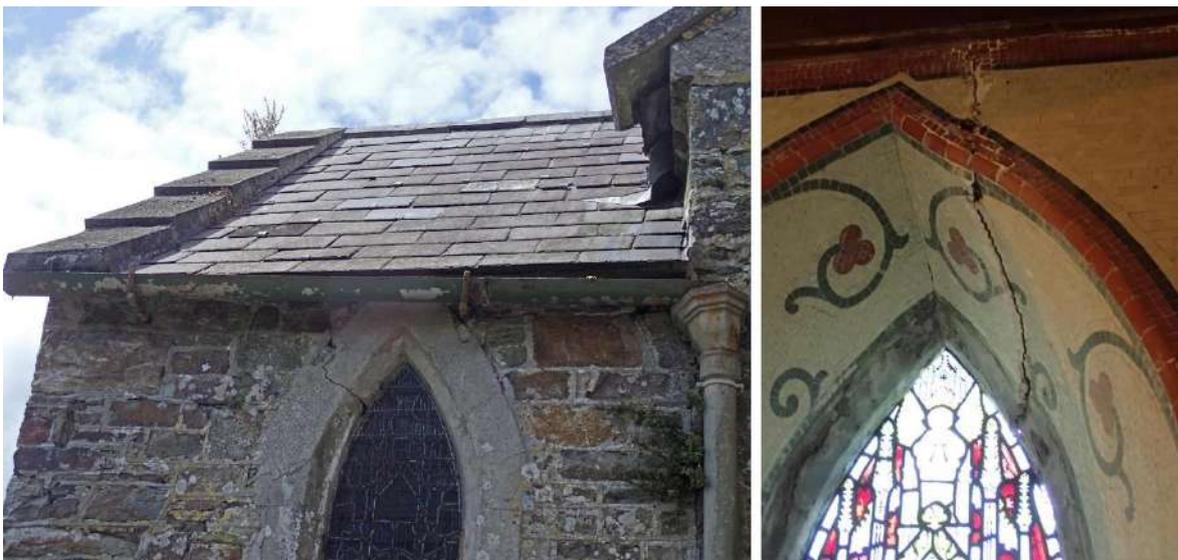
Fig.33: The south transept also shows structural cracks which exhibit internally also. This suggests that there are multiple routes for moisture to penetrate into the building fabric in this part of the building.

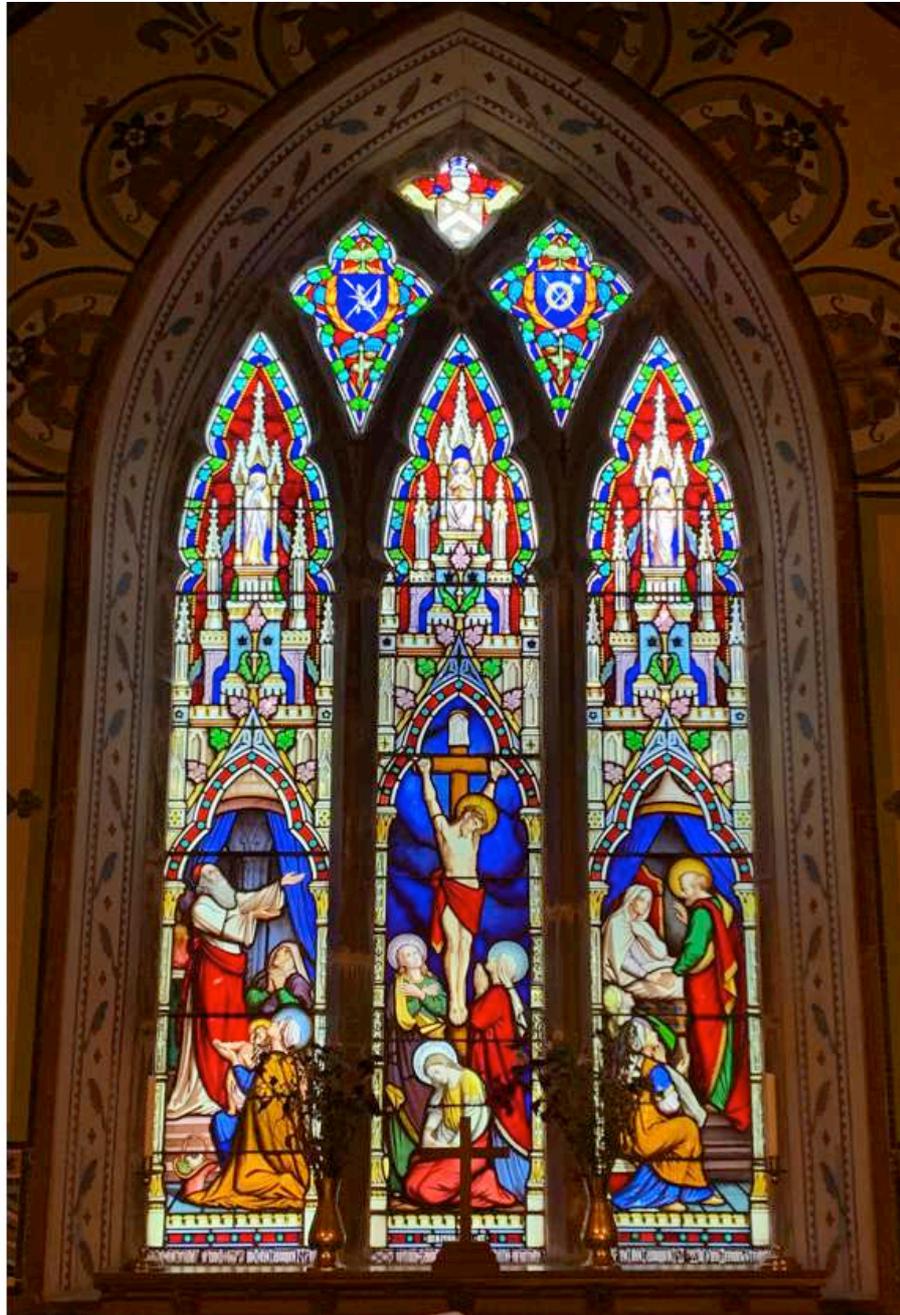
W1

**W1 East.** This window is the work of William Warrington & Sons circa 1865. It is the second set of windows installed in the Chancel opening. The first set, by Thomas Williment, have been rehoused in the west gable and behind the organ. From left to right, the window depicts Peter raising Dorcas, the Crucifixion of Jesus and the Presentation of the infant Jesus in the Temple.

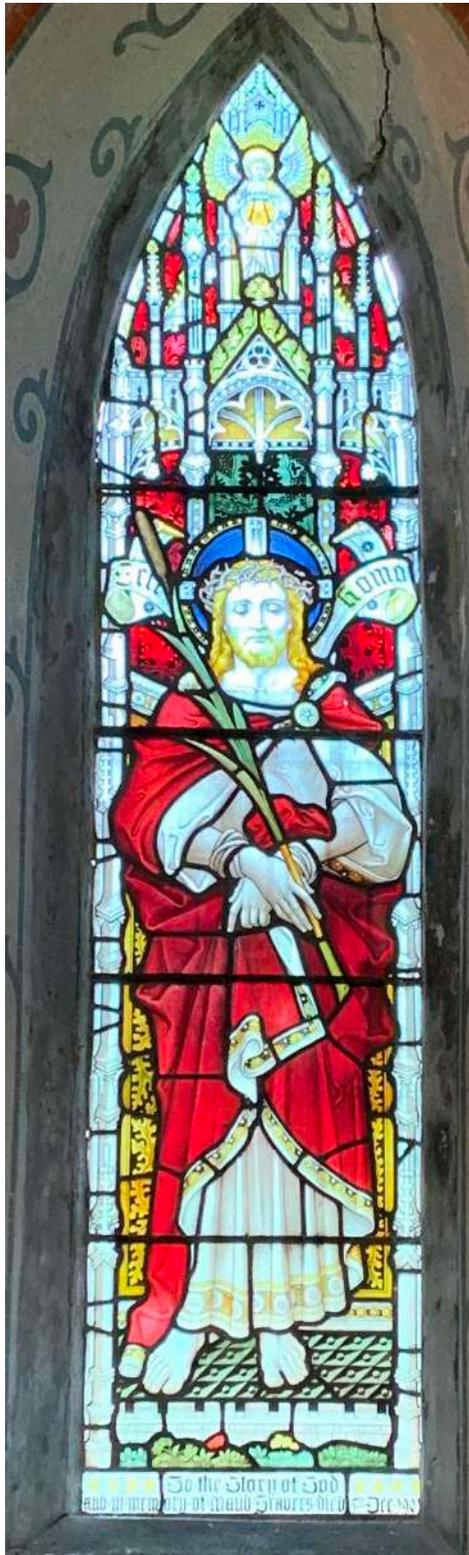
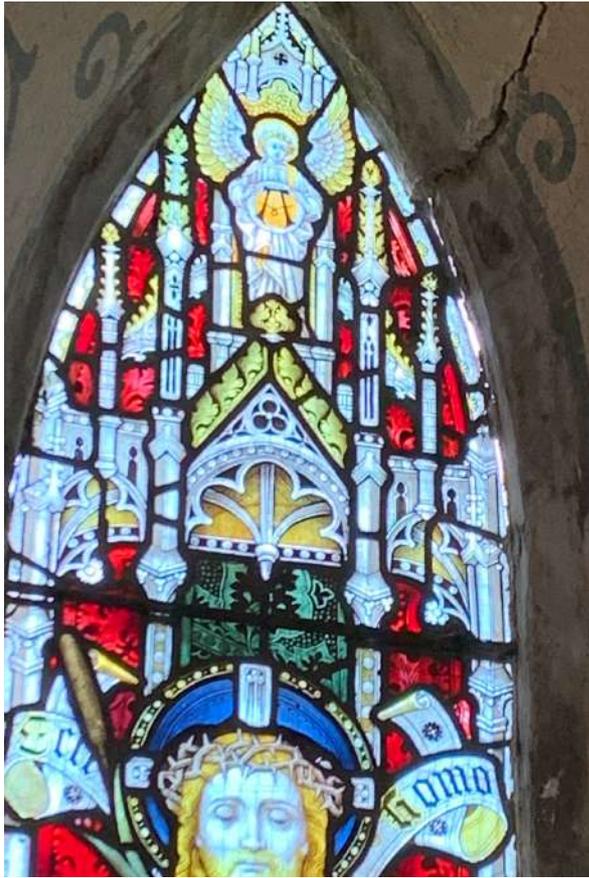
W2

**W2 South Transept, East Return.** The window is from the studio of Clayton and Bell and was designed by the renowned and prolific stained glass designer George Daniels circa 1901. Daniels was one of the most prolific freelance artists of his time. He worked for several studios including Mayers of Munich before establishing his own company. The window depicts Christ Condemned. It is in memory of Maud Travers. The approximate size of the window is 47cm x 208cm. This window is in need of major conservation work.

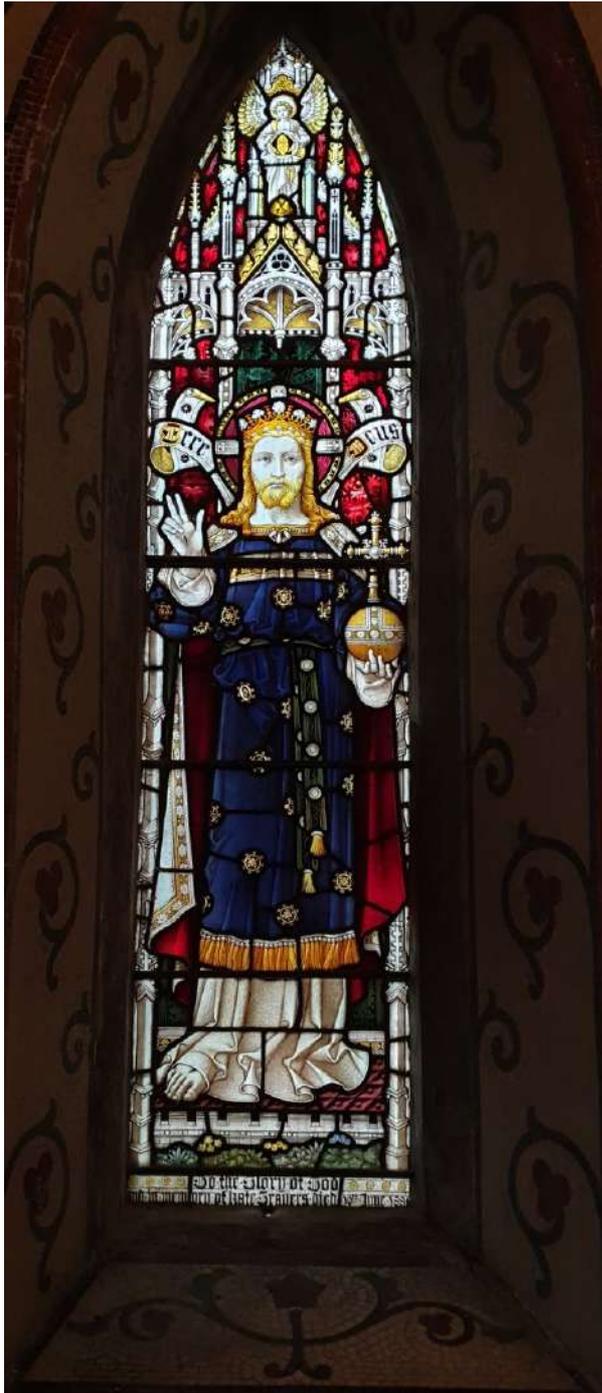
W4

Aria Stained Glass also conserved this window about twenty years ago. At that time the original ferrous metal support bars were replaced with solid brass. Natural hydraulic lime mortar was employed to point the window to the stone. All cracked panes of glass were repaired with conservation grade epoxy resin. The window appears to be aging well. No further conservation is required at this time.

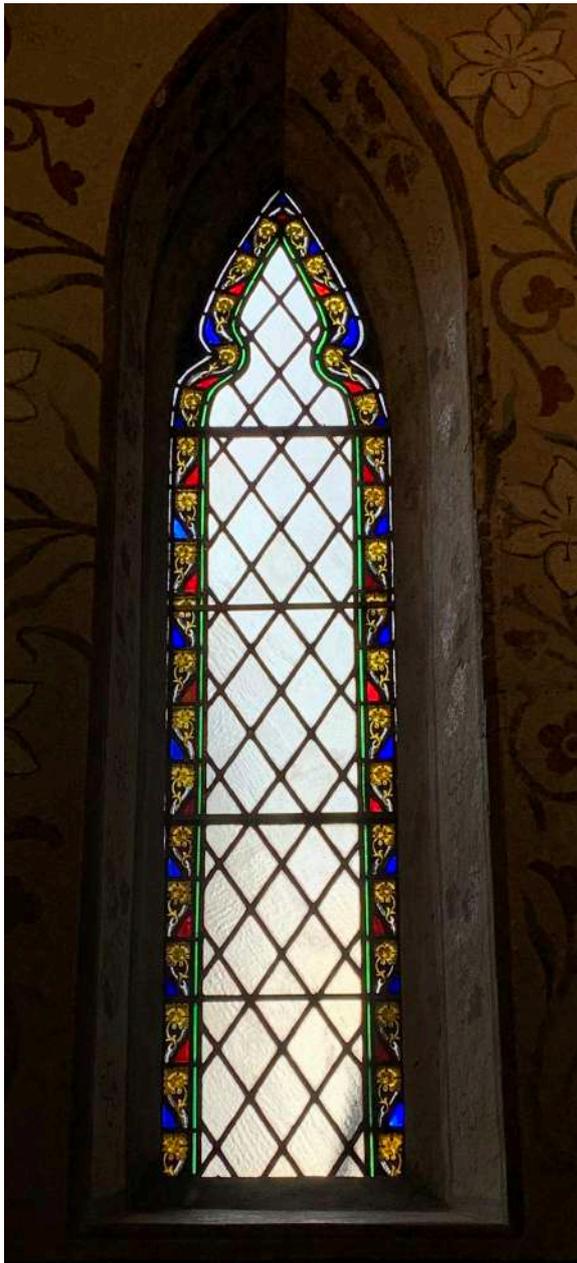
W7

It is comprised of a diamond quarry background with lightly decorated borders. This window has just been conserved by Aria Stained Glass where all of the original glass has been retained. Cracked panes have been sealed with epoxy resin, previously poorly painted replacement glass was replaced by our resident artist Marija Kovac. Each replacement piece was signed and dated on its edge. The window was resealed using lead that matched the profile of the original lead. We replaced the ferrous metal bars with stainless steel. The window was sealed using natural hydraulic lime mortar. It is approximately 47cm x 229cm.
