*Church of the Ascension, Timoleague  
Conservation Report*

## **1.0 Introduction**

This report has been carried out on behalf of our clients, The Vestry of Kilgarriffe Union of Parishes, who requested a Conservation Plan for the Church of the Ascension, Timoleague. It is located in Cork County. The Church is a protected structure (RPS ID 01375) and is listed on the National Inventory of Architectural Heritage (Reg No. 20856005). It is an Anglican Church dating from the early 1800s, with later additions.

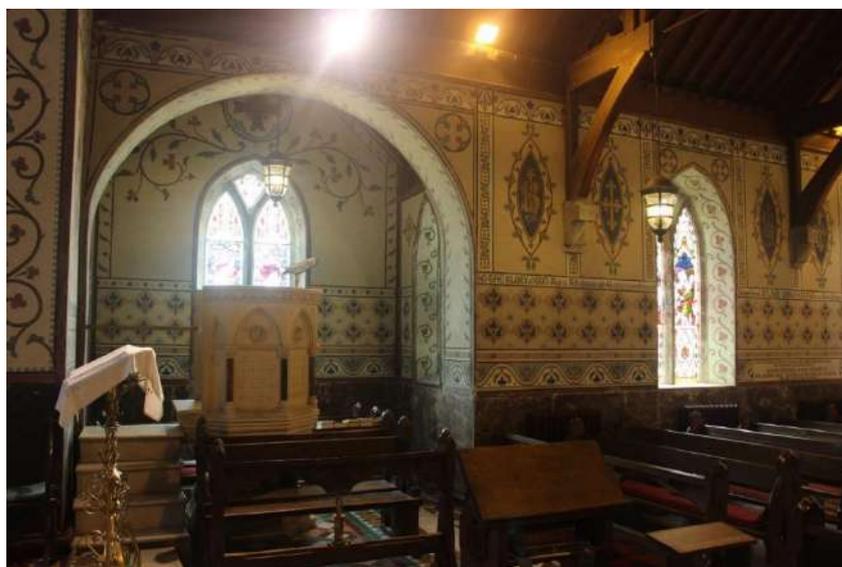
Nave-View to South Transept

A large round headed arch opening leads into the south transept. Windows are located to the three sides. This is the area showing the greatest image of damage in the church, both as a result of the poor condition of the roof and the movement which has occurred over time. Significant cracking is visible above the windows to the east and west. Minor water staining is visible on the roof. The marble wainscot is loose, and damage is visible to the mosaics throughout. Surface moisture readings of around 18% were recorded. The floor is suspended timber and opening up works indicated a significant level of decay present.

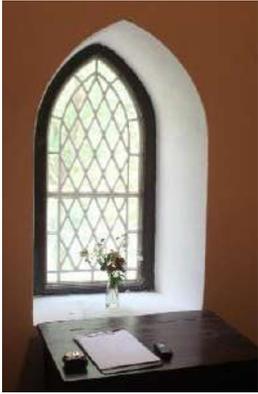
1

1. Window-Timber frame, diamond leaded window, clear glass
2. Timber boarded ceiling
3. Recess with built in storage
4. Vertical boarded timber door with pointed arch in square headed recess
5. Recessed safe with metal door- fireplace originally
6. Vertical boarded timber door with pointed arch in square headed recess

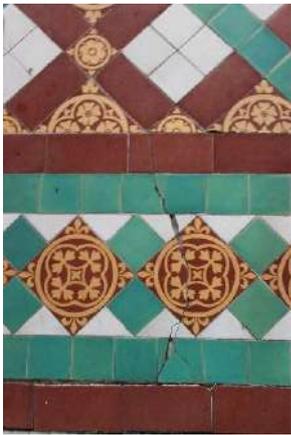
1

1. Detail of Minton encaustic tiles- cracking visible
2. Crack in floor tiles caused by movement.
3. Brick build-up uncovered behind damaged marble step
4. North Roof- Angels in Tempura paint. Mosaics read- *To the Glory of God and in Memory of*
5. North Roof- Angels in Tempura paint. Mosaics read- *Laura Isobel Travers died 25 June 1906*
6. Painted ceiling to chancel, mosaics to arch, timber ceiling to nave
7. View of chancel with central east window.

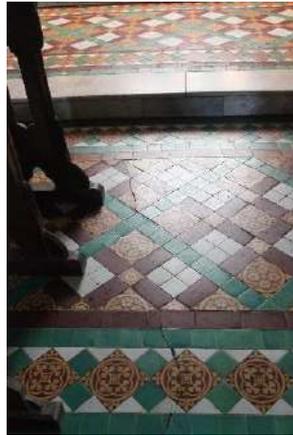
2

significant depth. Movement cracking is visible to this floor. The cause of this movement is unclear. The marble step at the perimeter is loose in a number of locations and needs resetting. Investigations are required to establish the cause of the movement.

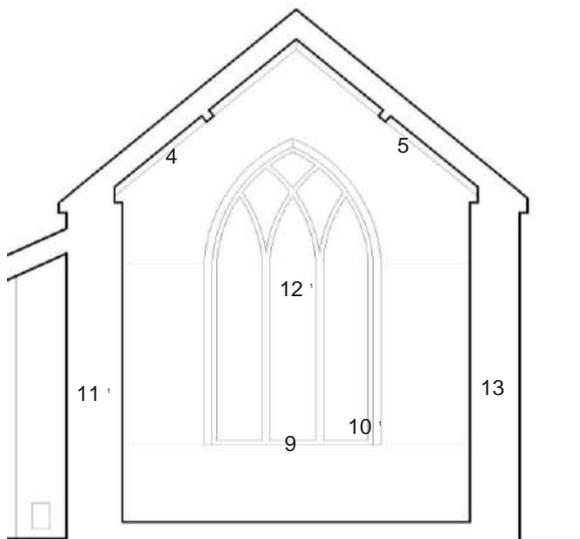
14

8. Detail of roof painting and mosaics to window opening
9. Damage to mosaics on window cill
10. Window detail of crucifixion
11. North wall mosaics above marble wainscot
12. Pointed arch stained-glass window with three light intersecting tracery and over-lights.
13. South wall mosaics above marble wainscot
14. Warrington Signature to window
15. Date to window - 1865

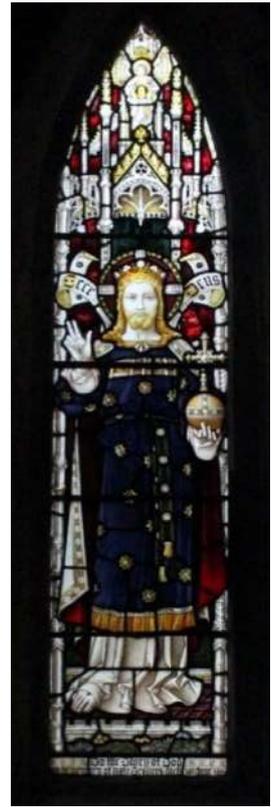
5

1. View towards roof with minor stains from water ingress visible
2. Crack above west window
3. Detail of mosaics to west wall
4. Damage to mosaics at corner edge
5. Pointed arch stained-glass window to west
6. Detail of damage to mosaics at corners

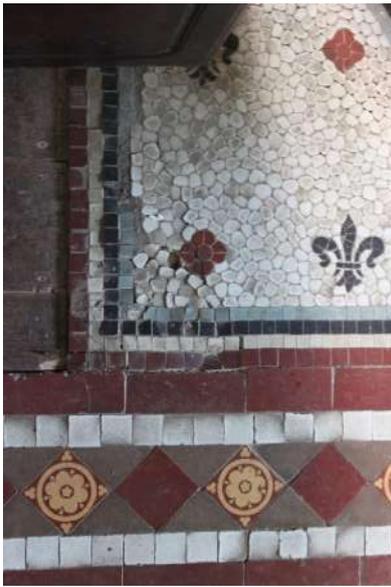
1

1. Floor detail – damage visible to tiles
2. Opening up to nave floor- rot present
3. Central aisle with geometric tiles
4. Hammer beam roof
5. View of south wall

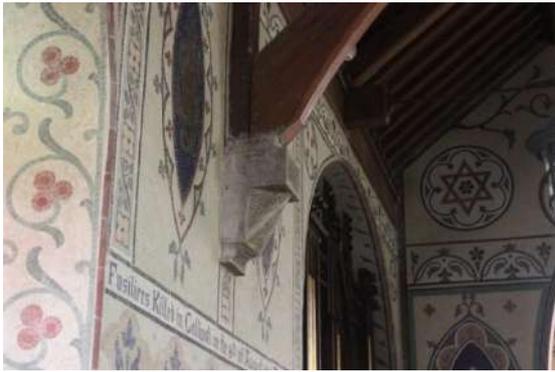
1

1. View towards nave roof
2. Dressed limestone corbel supporting roof structure
3. Light fittings- note that original lamps erected circa 1895
4. Section of floor replaced to north-west corner
5. Radiators installed throughout, circa 1919.
6. Opening up works – considerable dry rot present

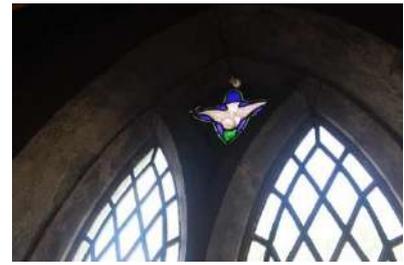
4

1. Organ installed c1890
2. Pointed arch window to west
3. Plaque
4. Window to north-detail of stained glass over-light
5. Clear glass diamond latticed window to north
6. Geometric floor tiles

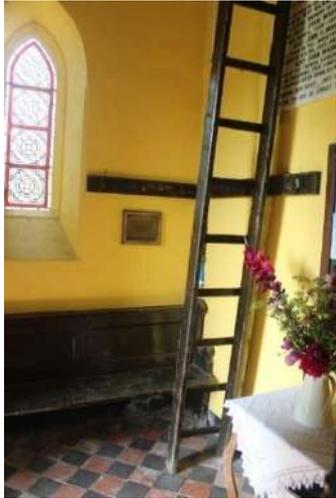
1

1. View of ladder to upper levels of bell tower
2. View of roof- water staining visible
3. Plaque dating the clock to 1908
4. Stained glass window with splayed reveals to west
5. View towards nave
6. Level stone threshold with diamond tiles
7. View of bell with timber bell frame
8. Exposed stone walls in upper levels of bell tower
9. Parapet pinnacle details
10. Flat lead roof
11. Corrosion to iron caused by damp ingress in bell tower

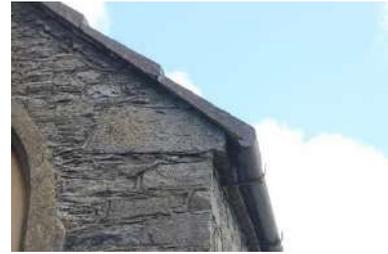
3

1. West Elevation
2. View of bell tower
3. Stone coping stones to nave
4. View of bell tower
5. Corrosion to rainwater goods
6. Vertical boarded timber door with pointed arch
7. South Elevation
8. Cut limestone window surrounds
9. View of south transept
10. Corrosion to rain water goods on south transept
11. Limestone surrounds with detail of cement pointing
12. View of south transept roof with concrete coping stones to gable

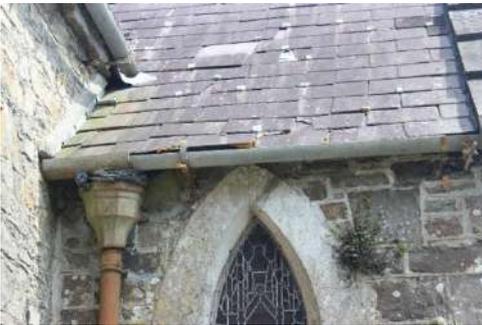
13

- 13. Corrosion to down pipe. Slipped slates and inappropriate expanding foam repairs visible
- 14. View of arch head near ground level- possible crypt below
- 15. Stone coping to nave
- 16. Ventilation brick to south transept

The roof is of critical importance. Slipped slates are found throughout the roof to the nave and south transept. Water ingress is especially visible at the west gable of the nave at the abutment with the southern roof slope. The roof should be made watertight as a temporary measure. This should be done as a matter of urgency, before the end of 2019. Rainwater goods should be replaced where they are corroded and allowing water to saturate the walls. The roof will require subsequent reroofing (see below).

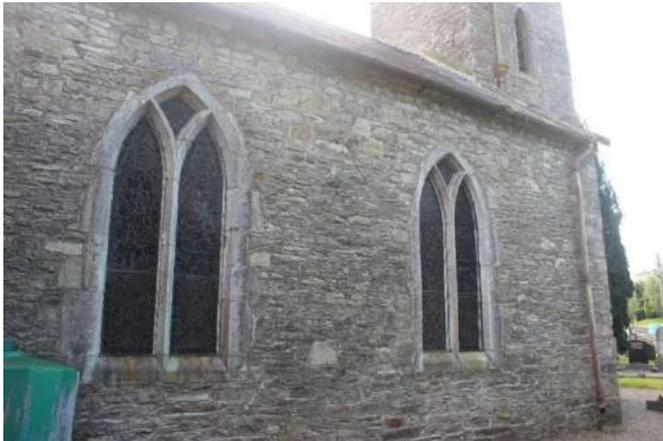
1

1. View of north elevation
2. Rain water goods
3. Rainwater goods
4. View of coping stones
5. Cement pointing
6. View of north side of nave

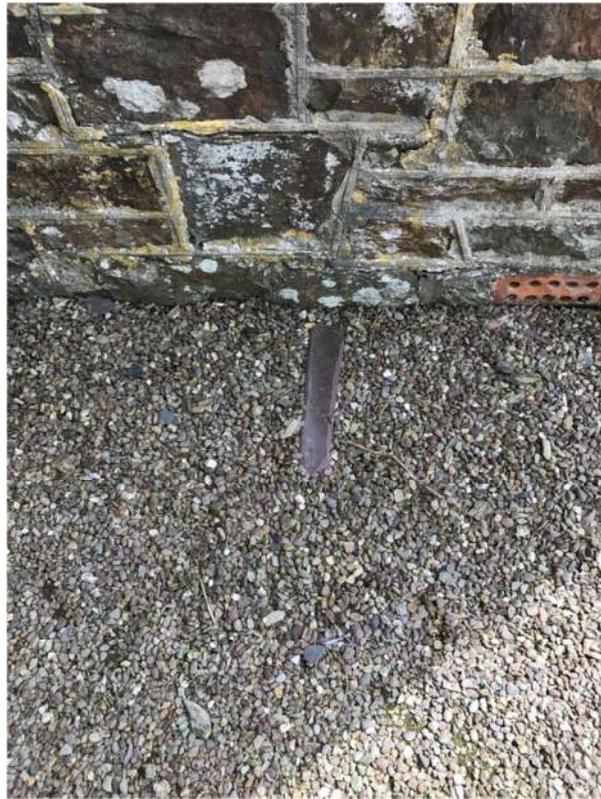
**Slate fragment**

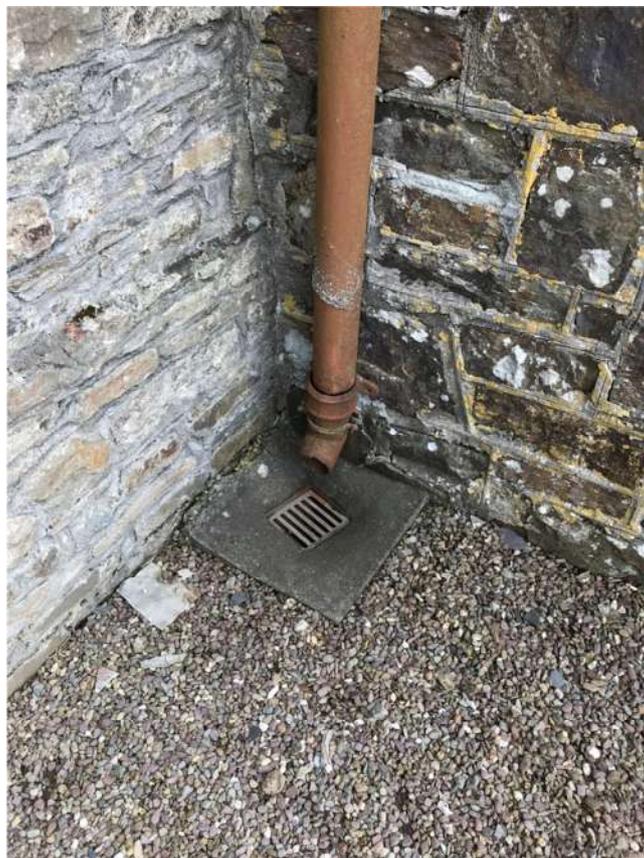
**Rainwater downpipe and gully**

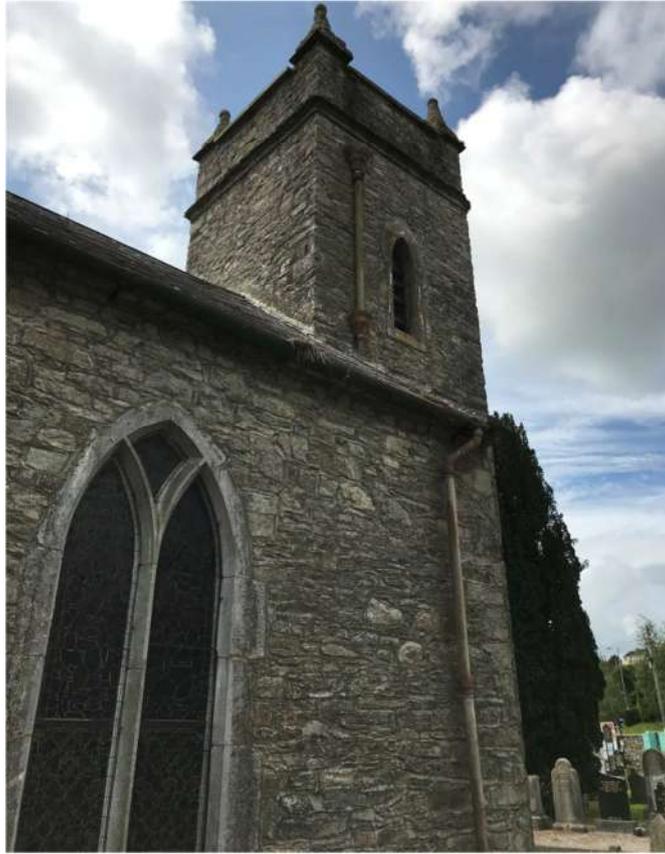
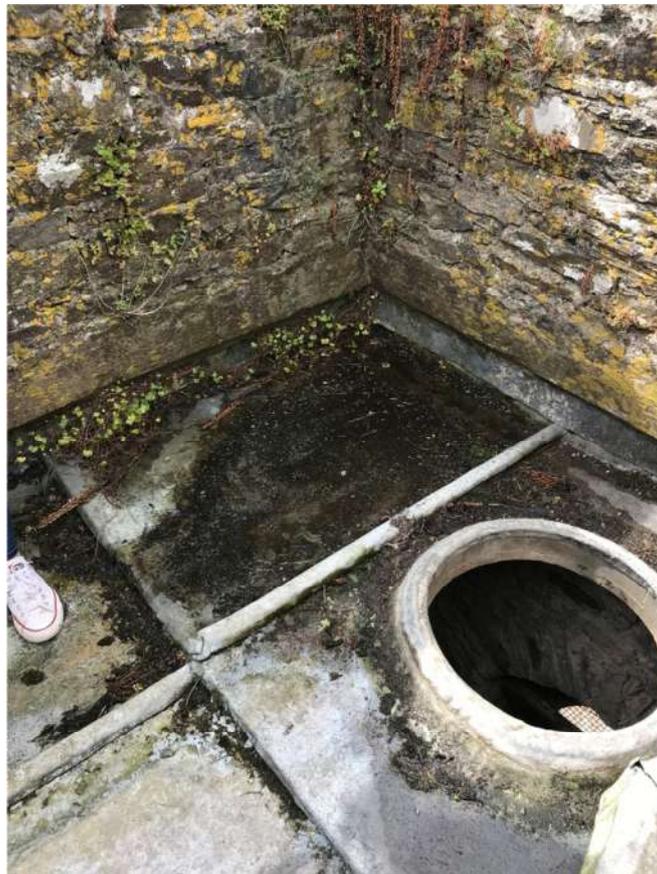
Water ingress is visible in the bell tower roof. The source of this should be established and temporary repairs should be undertaken to address this issue. The roof will require subsequent reroofing (see below).

**Backfall / ponding in bell tower flat roof at corner**

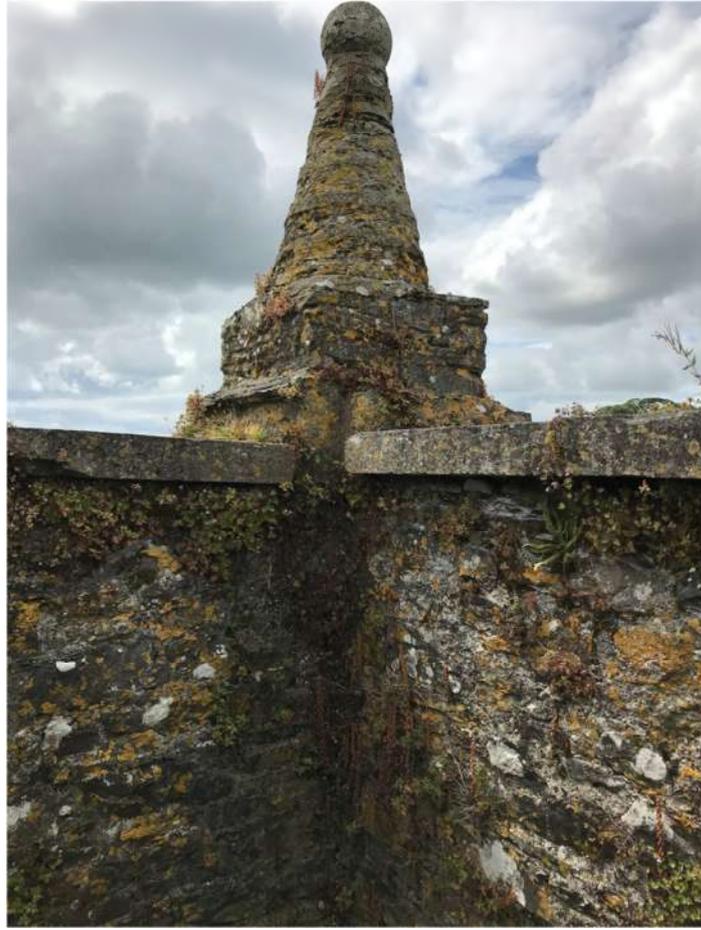
**Surface vegetation at bell tower parapet wall**

1. Consider rendering the external walls of the church with a lime-based render.
2. Consider rendering the internal face of the bell tower parapet to reduce water ingress

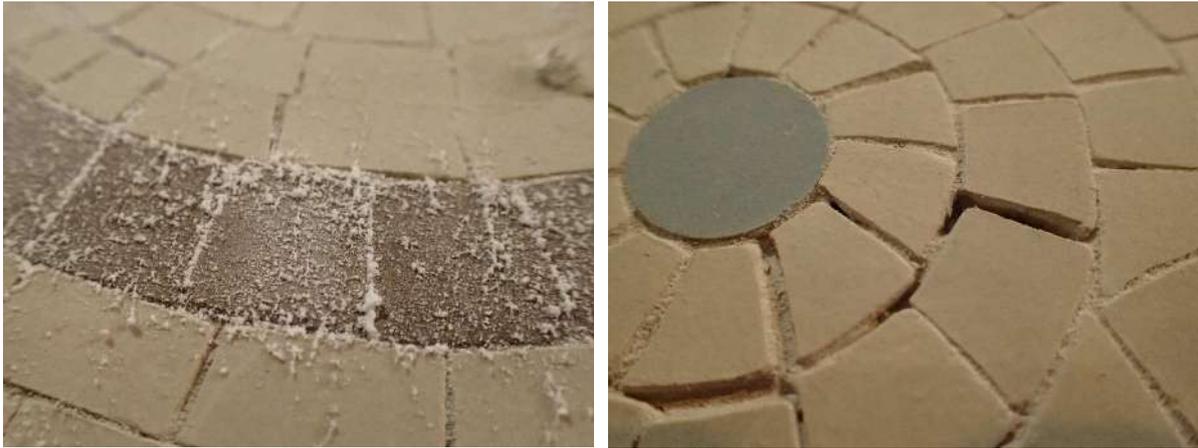
Fig. 9: Salt crystallisation leading to mortar dissolution between the tiles on the west gable of the nave.

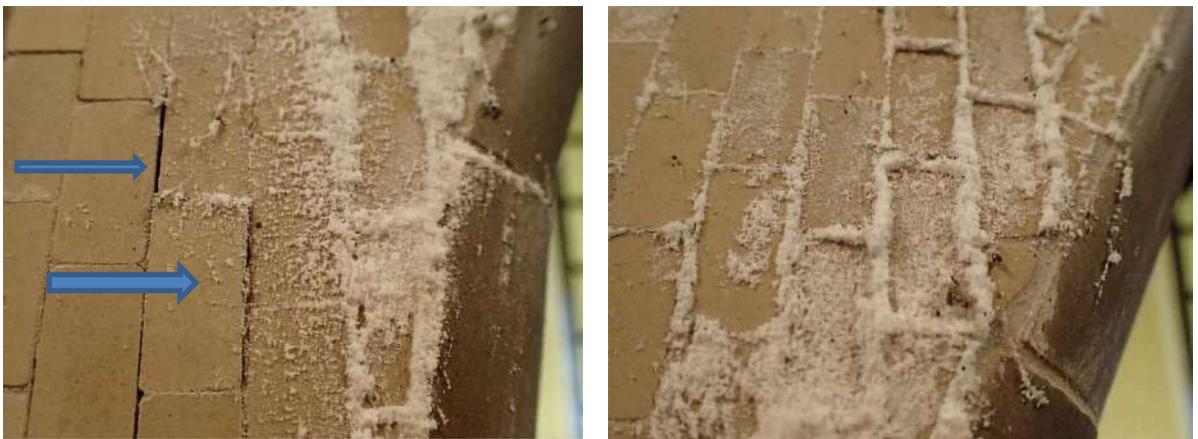
Fig. 10: Salt crystallisation at the arch surround of the doorway through the west gable, showing needle-like whitish efflorescence and tiles displaced once the mortar is lost (left, arrowed).

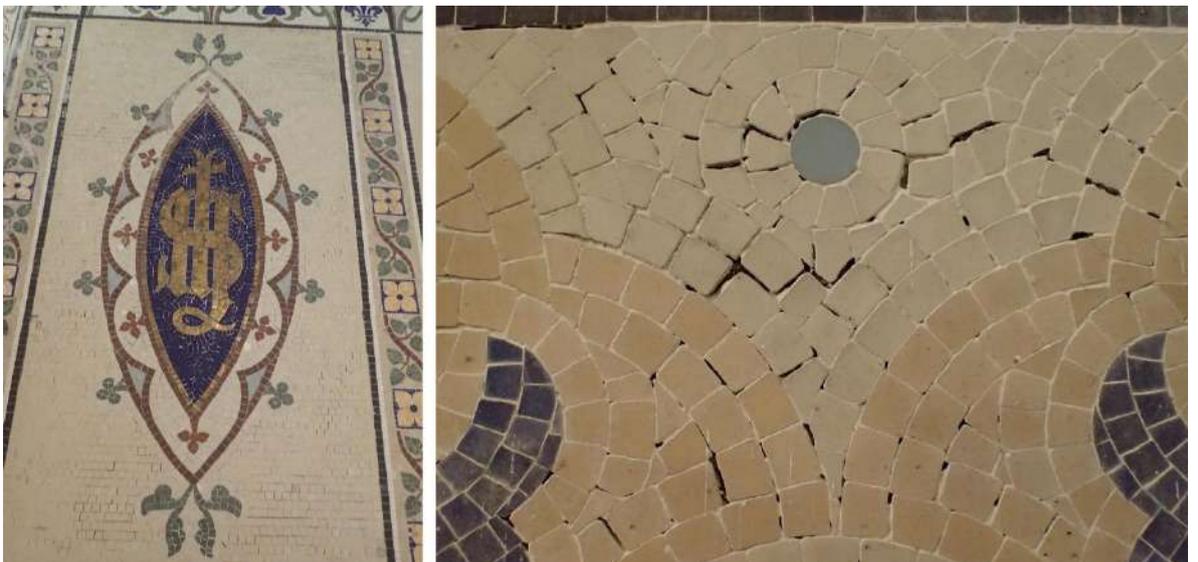
Fig. 11: Areas of lost mortar joints can be seen throughout individual panels suggesting that the processes causing the loss of the jointing mortars are diffuse throughout the wall fabric and not localised to specific areas. From a distance (left) the joints between the tesserae appear to be more visible, however, on close inspection (let) the mortar has been lost with tiles beginning to shift and destabilise.

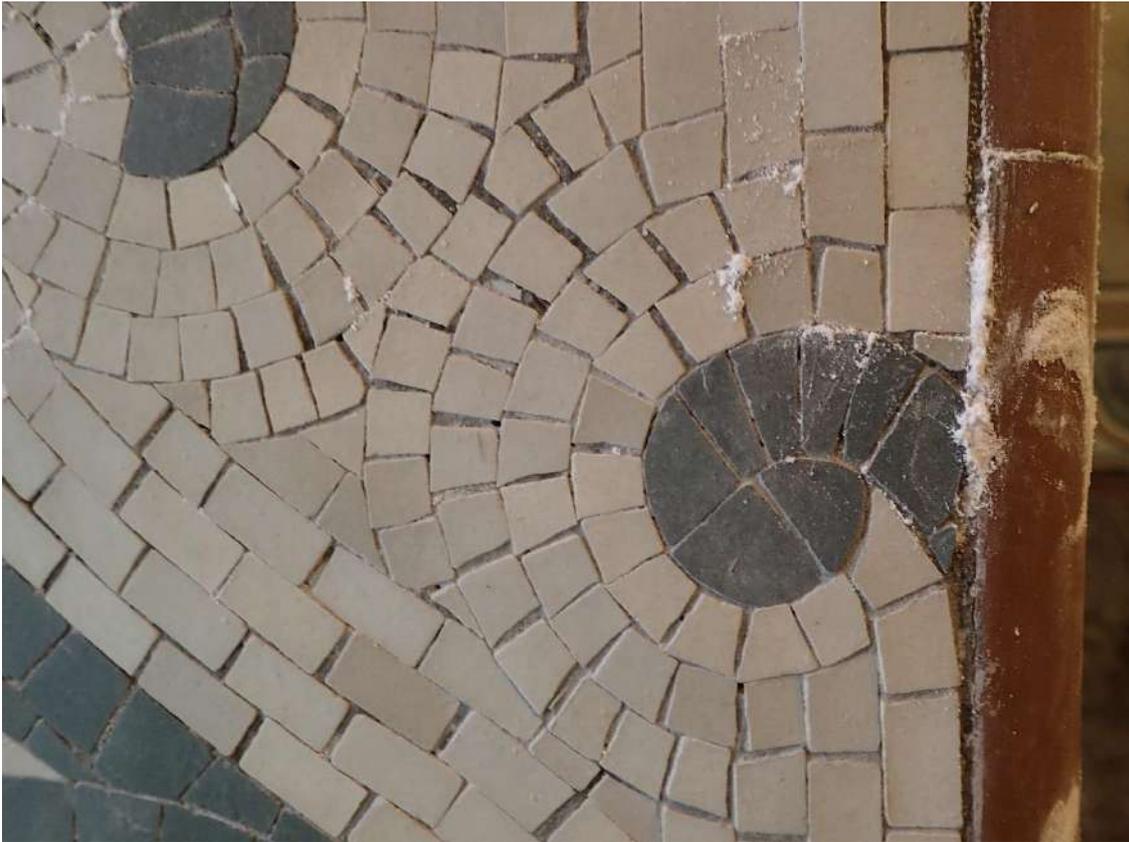
*Fig.12: Detail of the north wall of the nave adjacent to the north transept showing an area of widespread mortar loss accompanied by salt crystallisation suggesting the two processes are linked.*

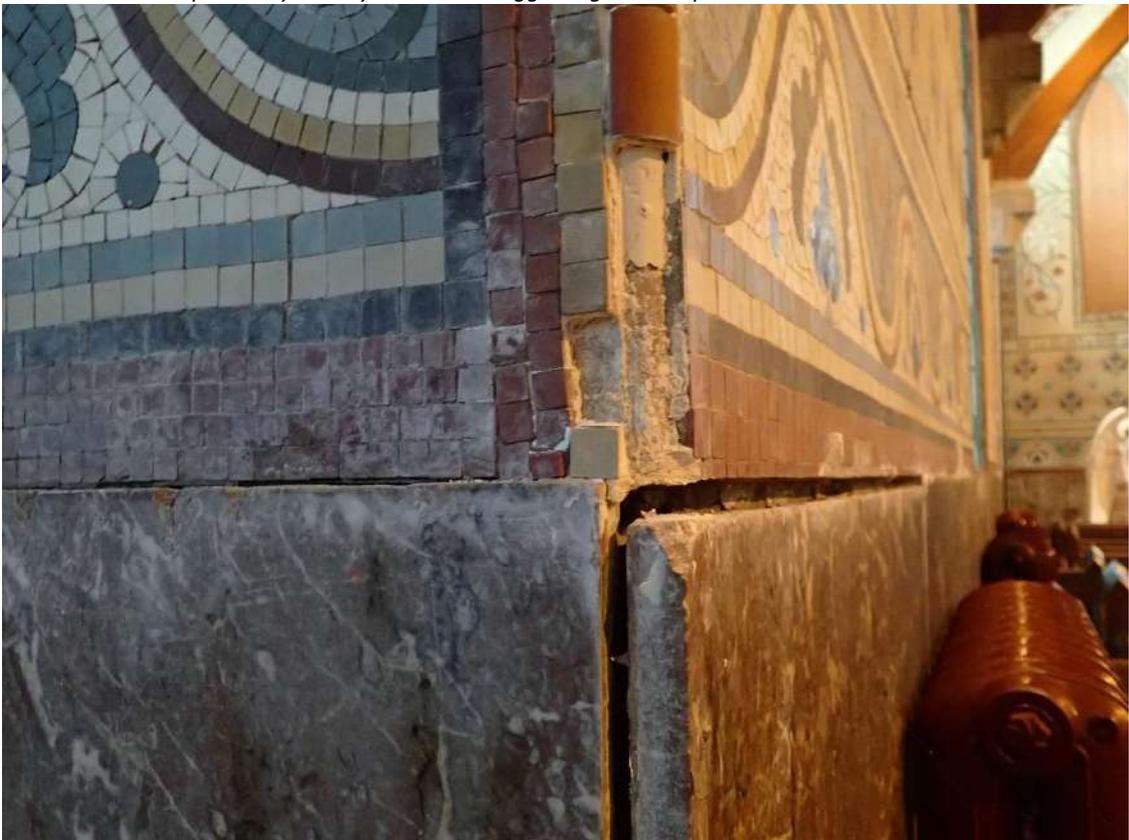
*Fig.13: View of the south wall of the nave adjacent to the south transept showing white deposits on the surface of the tiles and the marble, the displacement of the marble plinth and the detachment of tiles at the angle.*

**4.1.2 Detachment of Tiles:** The loss of mortar and salt action appears to combine in some areas leading to the destabilisation and detachment of tiles. This is apparent at the angles of the south (Fig.13) and north (Fig.14) transepts, the south-west corner of the nave, and tiles at windows and door openings.

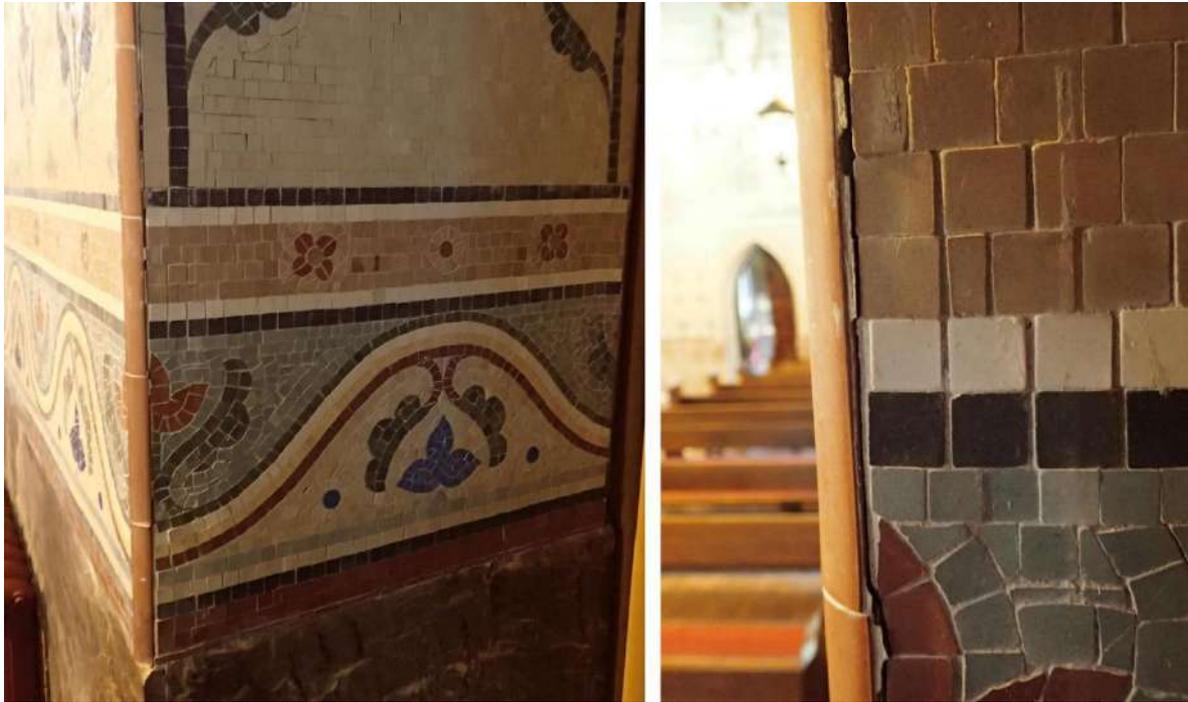
*Fig. 14: Mortar dissolution leading to displacement of angle tiles at the entrance to the north transept. Note salt crystallisation and dissolution of mortars depositing on the surface of the tiles. See also Fig.12.*

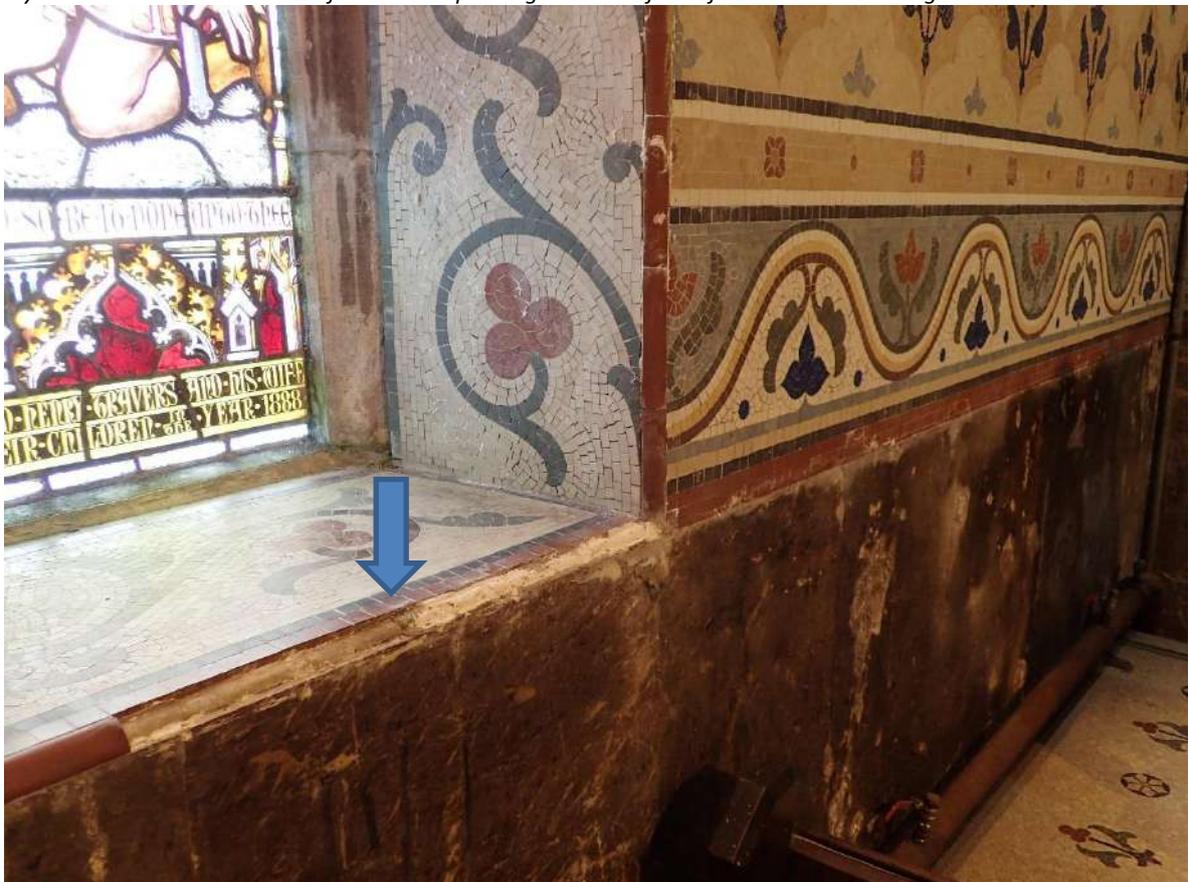
*Fig.15: Loss of angle tiles (arrowed), south elevation of the nave.*

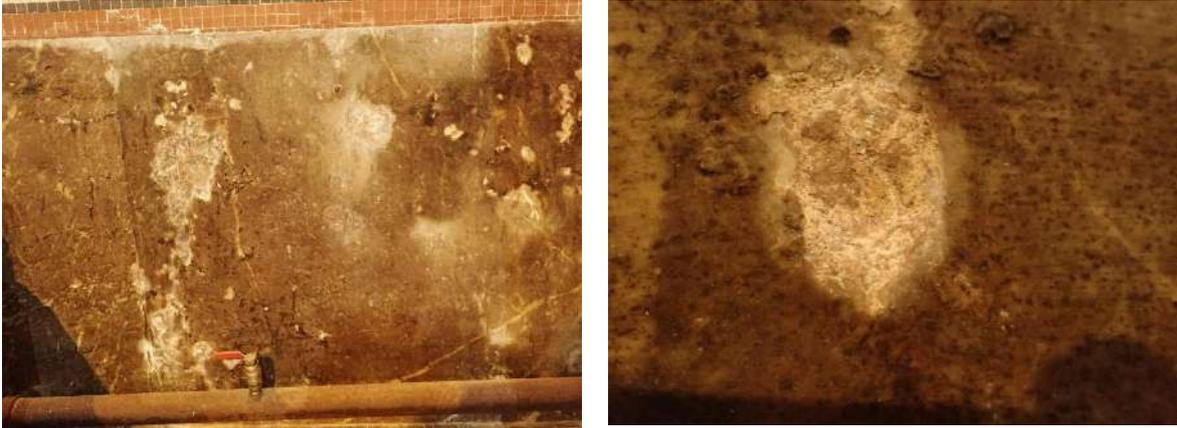
Fig.20: Salt crystallisation on the marble plinth on the south wall of the nave.

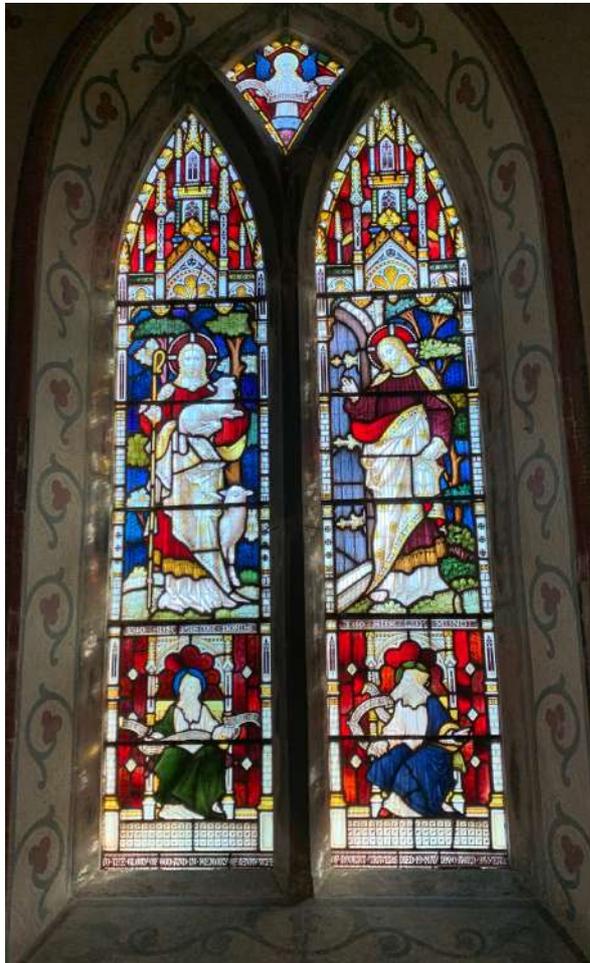
W3

**W3 South Transept.** This window is also from Clayton and Bell. It is not mentioned whether the window was designed by George Daniels or not. The window is comprised of two lancets and a quatrefoil. The left hand lancet depicts Jesus as The Good Shepard and the right as The Light of the World. The quatrefoil depicts an Angel with a scroll with the words, Sanctus, Sanctus, Sanctus. The approximate size of the lancets are 47cm x 229cm. This window is in need of conservation.

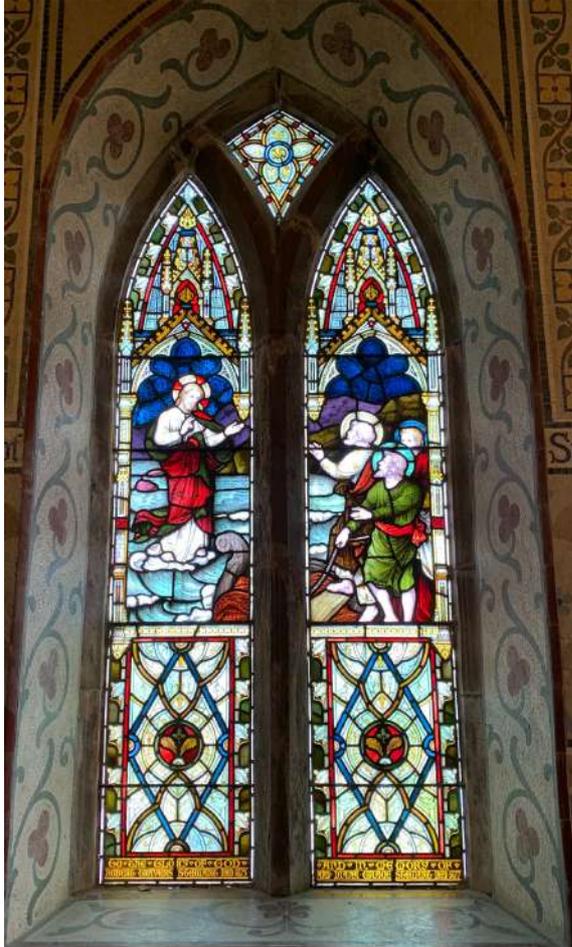
W5

**W5 South Nave, East Most.** This window is the work of Lavers, Barraud & Westlake, London. The design is attributed to Nathaniel Hubert John Westlake. The window is in memorial to Robert Travers, 1875. The window is comprised of two lancets and a quatrefoil. The lancets measure 47 cm x 229cm. The left lancet depicts Jesus walking on the water, the right, the disciples in their boat. The window is in need of conservation.

The glass is relatively good condition. There are a few hairline cracked panes.

The support bars are made of a ferrous metal. They are progressively rusting and threaten the surrounding stone and glass.

Cost of conservation €11,996 inclusive of vat.

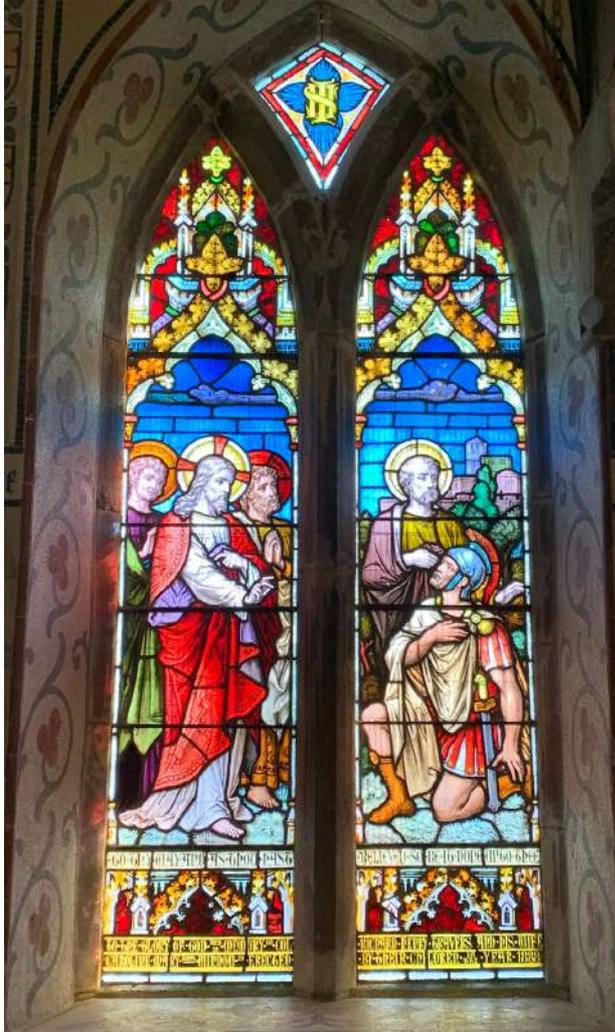
W6

**W6 South Nave, West Most.** This window is the work of the world renowned German studio Mayers of Munich & Co. It is comprised of two lancets and a quatrefoil. The window depicts Jesus healing the Centurion's servant. It is in memorial to Richard Henry Travers and his wife Caroline circa 1880. The size of the lancets are 47 cm x 229cm. The window is in need of conservation.

The stone column is cracked due to rust expansion from support bars.

The glass is in good condition.

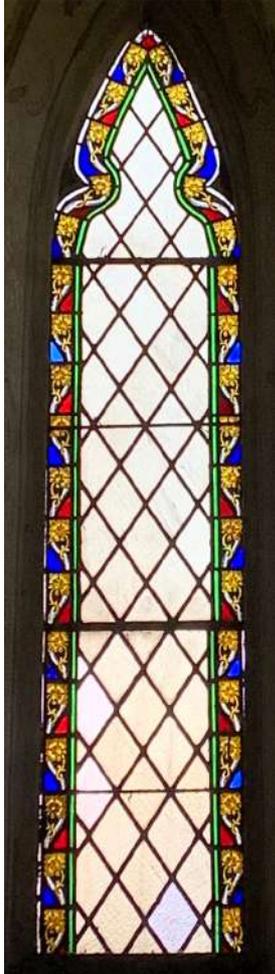
W8

**W8 West Gable, North Most.** This window is also most likely the work of Thomas Williment and one of the original Alter windows. It is in very poor condition. It has been repaired previously in places with temporary crude stop-gap repairs. The window sits askew in the opening and presents quite an eyesore. It is approximately 47cm x 229cm. The window is in dire need of conservation.

The lead is very weak and needs to be replaced.

There are a few cracked panes and poorly painted replacement pieces.

The support bars are made of ferrous metal and will require replacement along with the windows conservation.

The painted surface of the original pieces looks slightly worn. This window may be the cause of dampness in this area of the church.

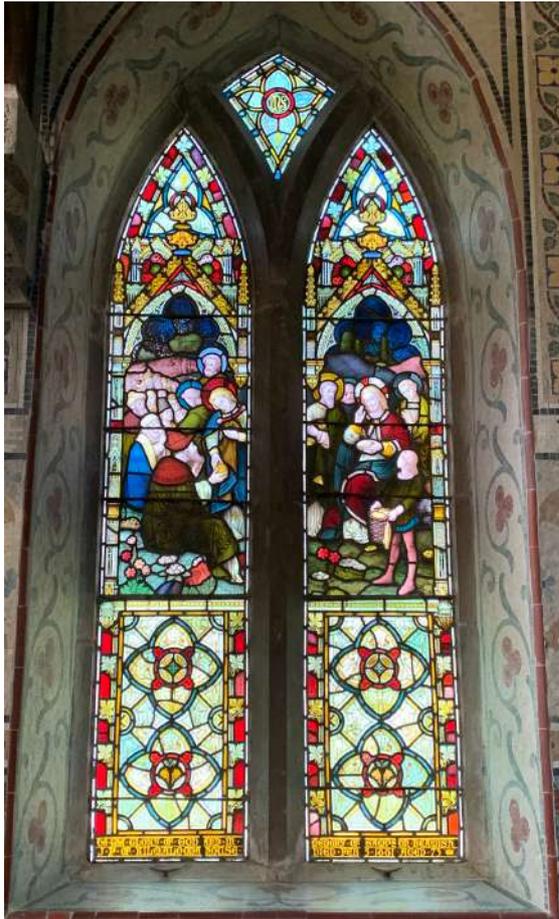
W9

**W9 North Nave, West Most.** This is the first window of the north elevation surveyed. Like the many of the other windows it is very old and in need of conservation. However, typical of windows on the north side of churches it receives less inclement weather than the other elevations and can therefore be considered less of a priority than the east, south or west elevation windows.

The lead of both lancets is worn, but slightly better than the lead of the other elevations.

The glass is in good condition.

The support bars are made of ferrous metal and are progressively decaying.

Cost of conservation €11,996 inclusive.

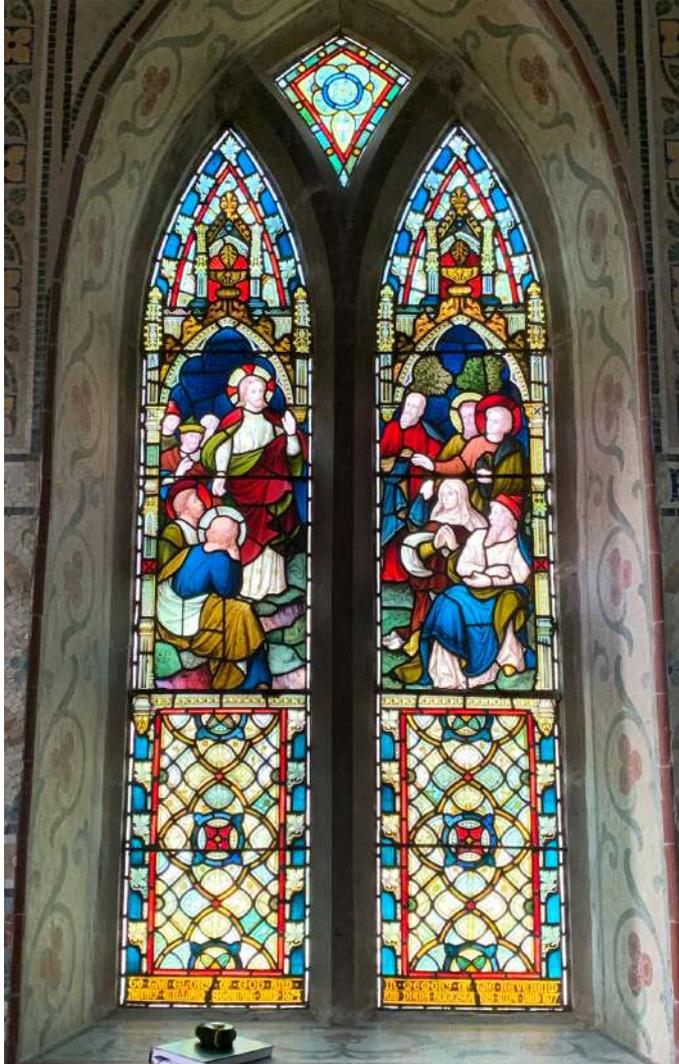
W10

The lead is worn, but stable.

The glass is in good condition.

The support bars are made of ferrous metal and are progressively decaying.

Cost of conservation €11,996 inclusive.

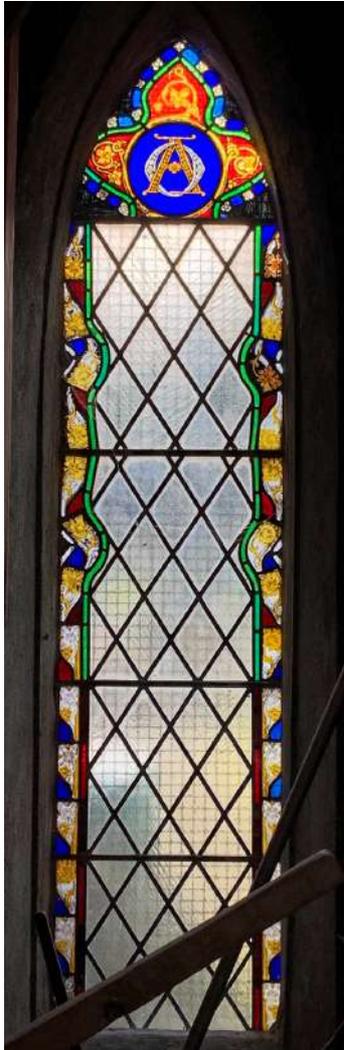
W11

**W11 North Transept, West Return.** This is a single lancet window. It is the work of Thomas Williment, like the West Gable Windows. It has been previously restored by Aria Stained Glass. The size of the lancet is approximately 47 x 229cm. This window is structurally sound and not in need of conservation at this time.

The lead is in good condition.

There are cracked panes of glass that have been sealed using conservation grade epoxy resin.

No conservation is required at this time.

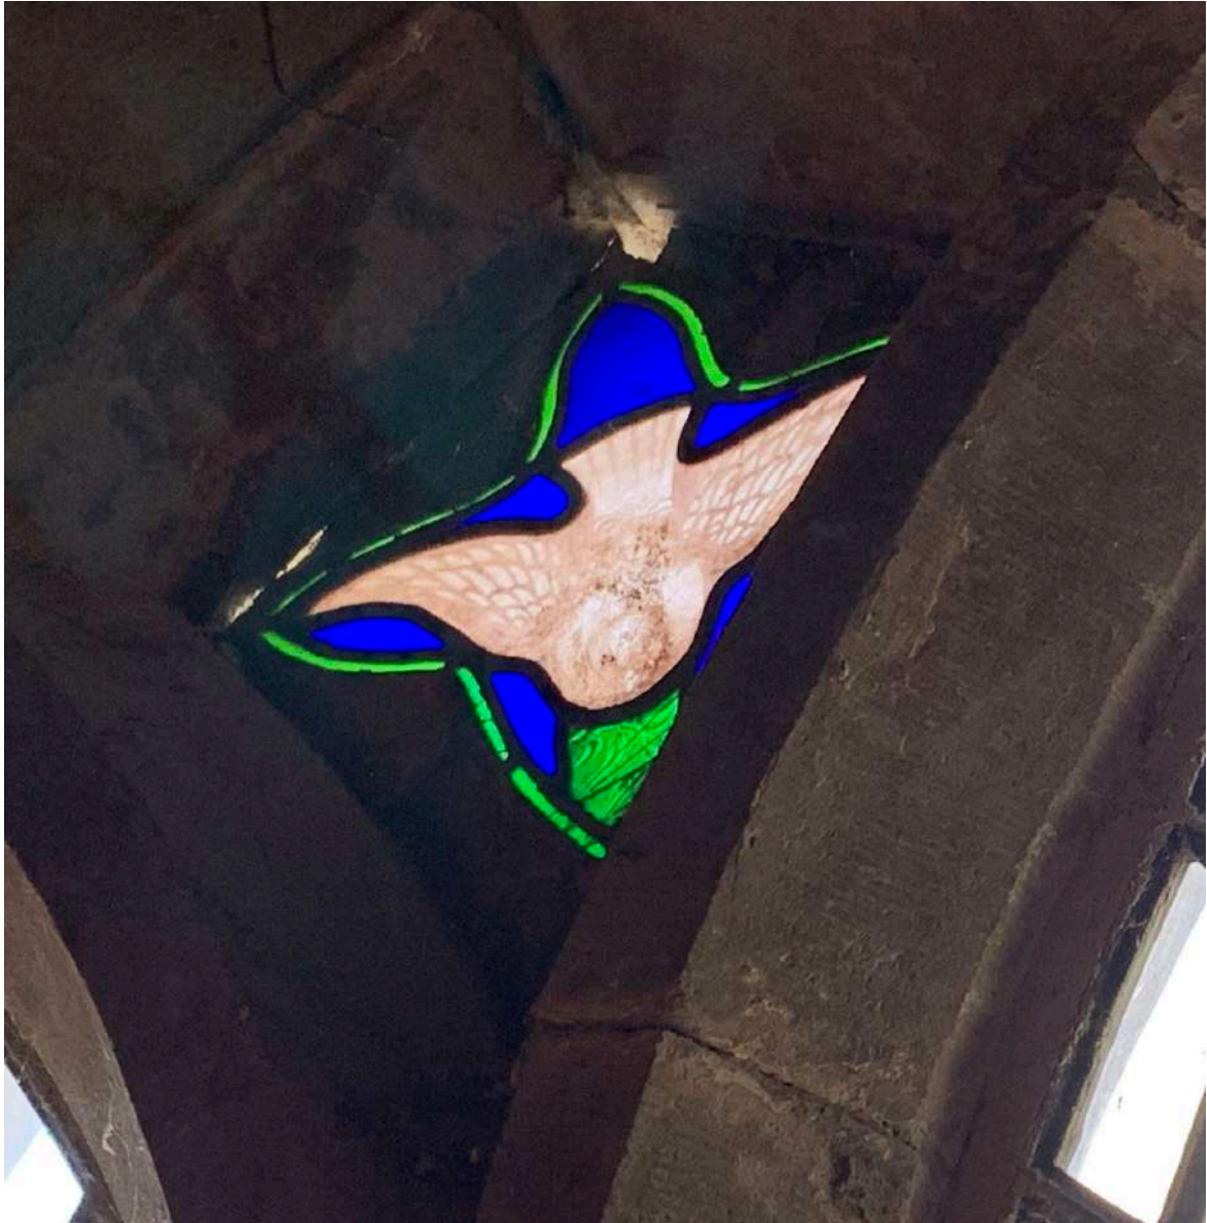
W12

**W12, North Transept.** This is a cast iron window. There are two lancets and a stained glass quatrefoil. The quatrefoil looks like it may be part of a Thomas Williment window. It is a Dove descending, a sign of the Holy Spirit.

The quatrefoil probably dates back to circa 1812. It looks weak. Some of the background glass is cracked and loose. This section should be attended to as soon as possible. Otherwise a historical piece of painted glass may be lost.

Cost of conserving the quatrefoil in conjunction with other works €750 inclusive.

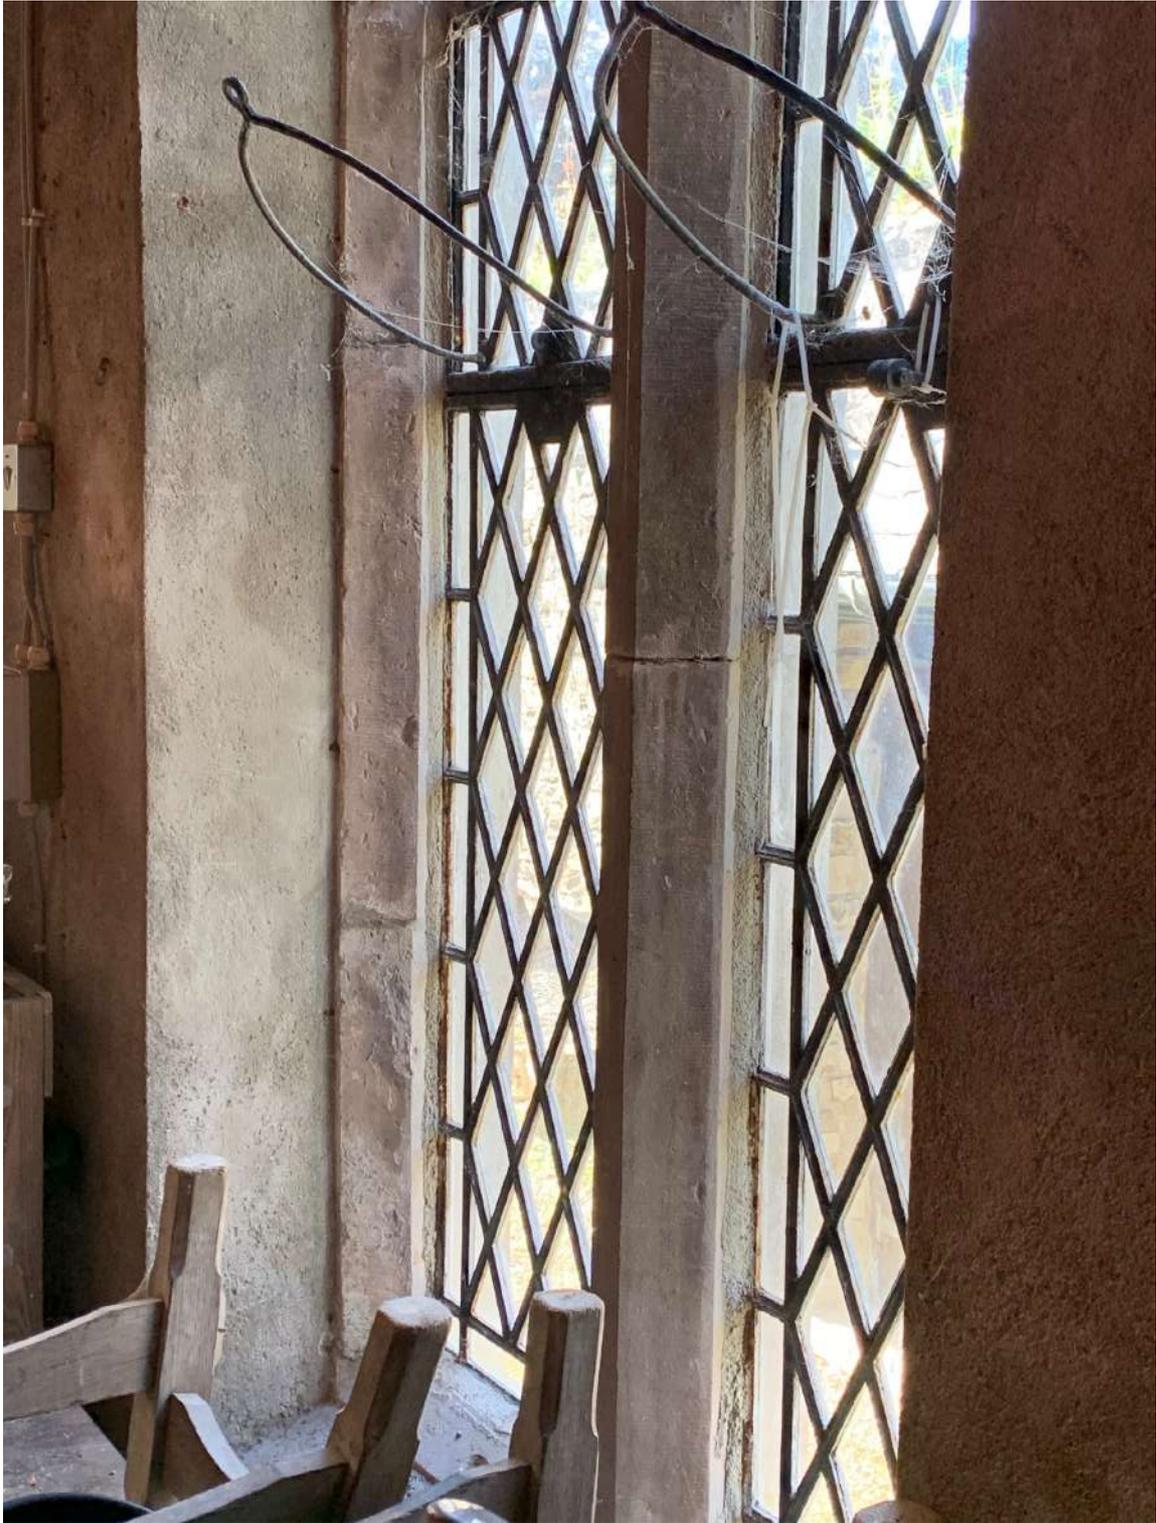
W12, cast iron section.

The cast iron section is in pretty good condition. However, it could use a coat of paint.
