*Church of the Ascension, Timoleague  
Conservation Report*

## **1.0 Introduction**

This report has been carried out on behalf of our clients, The Vestry of Kilgarriffe Union of Parishes, who requested a Conservation Plan for the Church of the Ascension, Timoleague. It is located in Cork County. The Church is a protected structure (RPS ID 01375) and is listed on the National Inventory of Architectural Heritage (Reg No. 20856005). It is an Anglican Church dating from the early 1800s, with later additions.

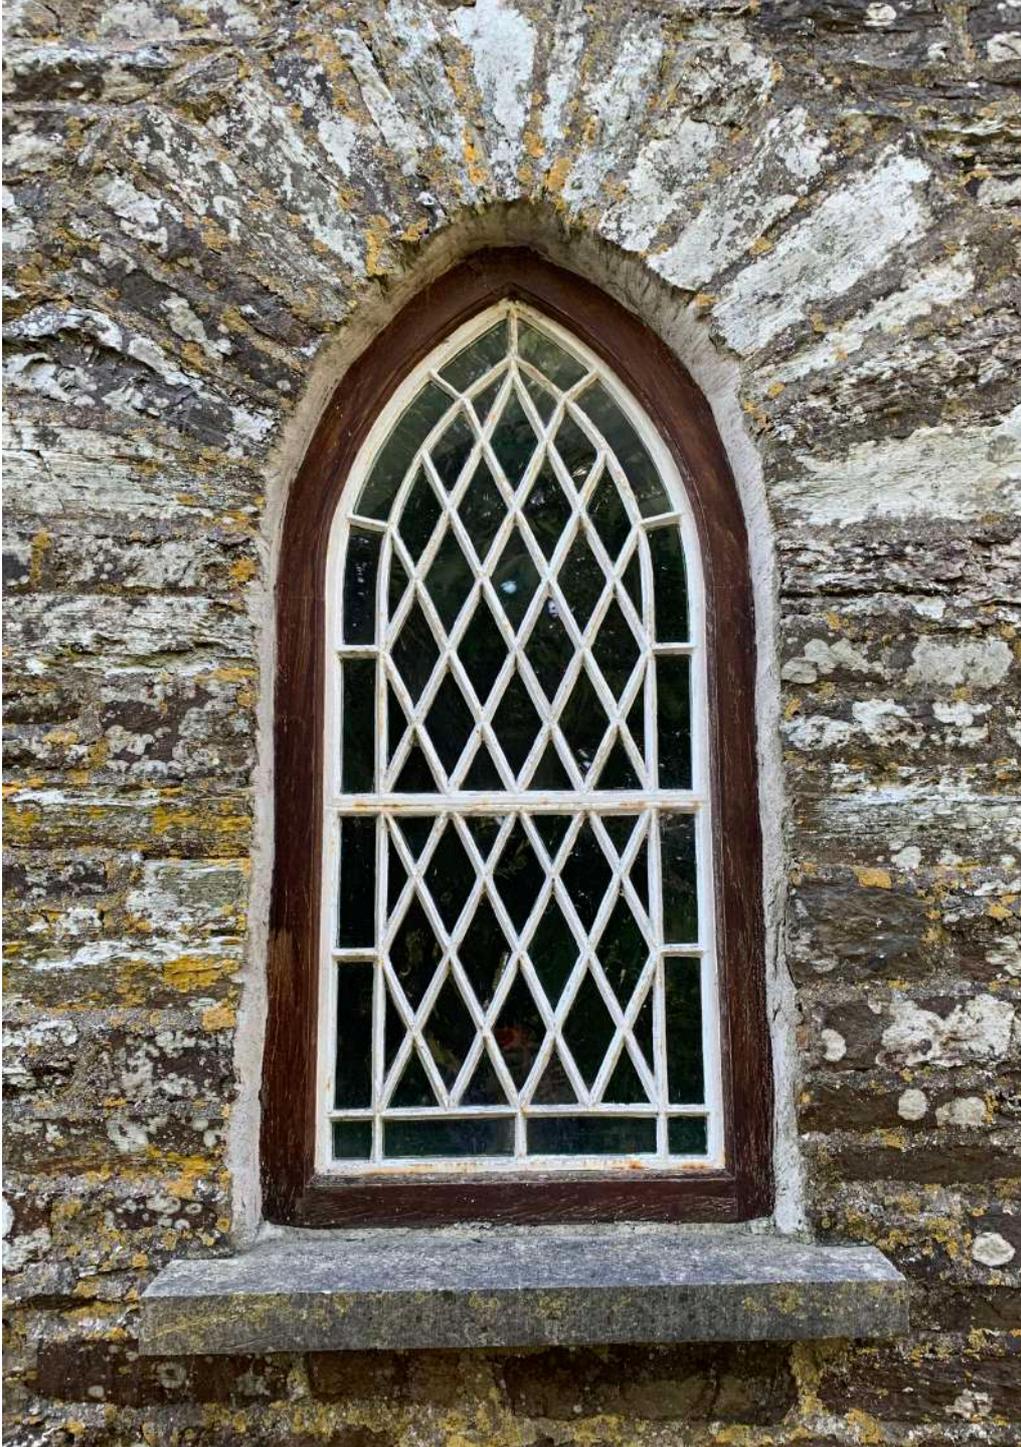
Vestry

**W14, Vestry.** This is a cast iron window set into a timber frame. It is structurally sound, although the wood and metal could use a coat of paint.

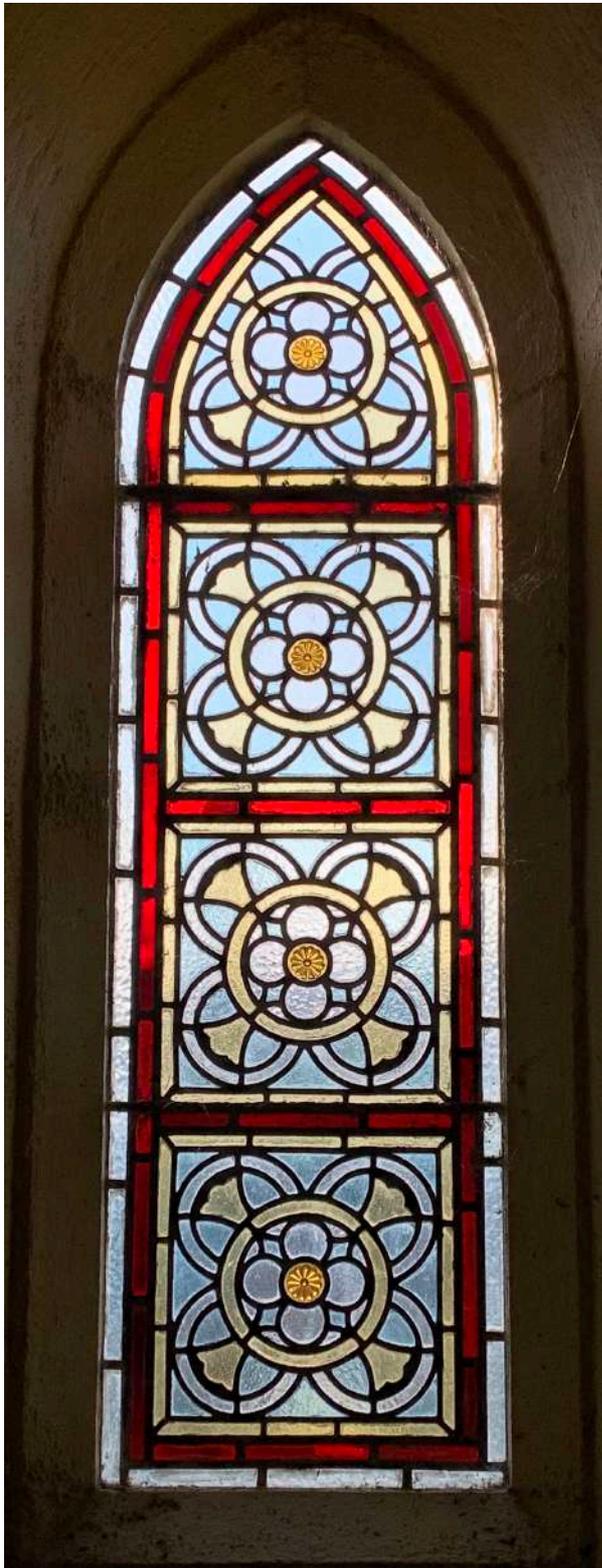
W13

**W13, Porch.** This is a decorative leaded light without painted detail. It is in good condition. There are ferrous metal bars that could be treated with Owatrol as a primer and a couple coats of a good quality metal paint to prevent damage through rust expansion.
